May 29, 2024

Re: Arborist Report for 516 Lakemead Way, Emerald Hills

TREE PROTECTION PLAN

for 516 Lakemead Way

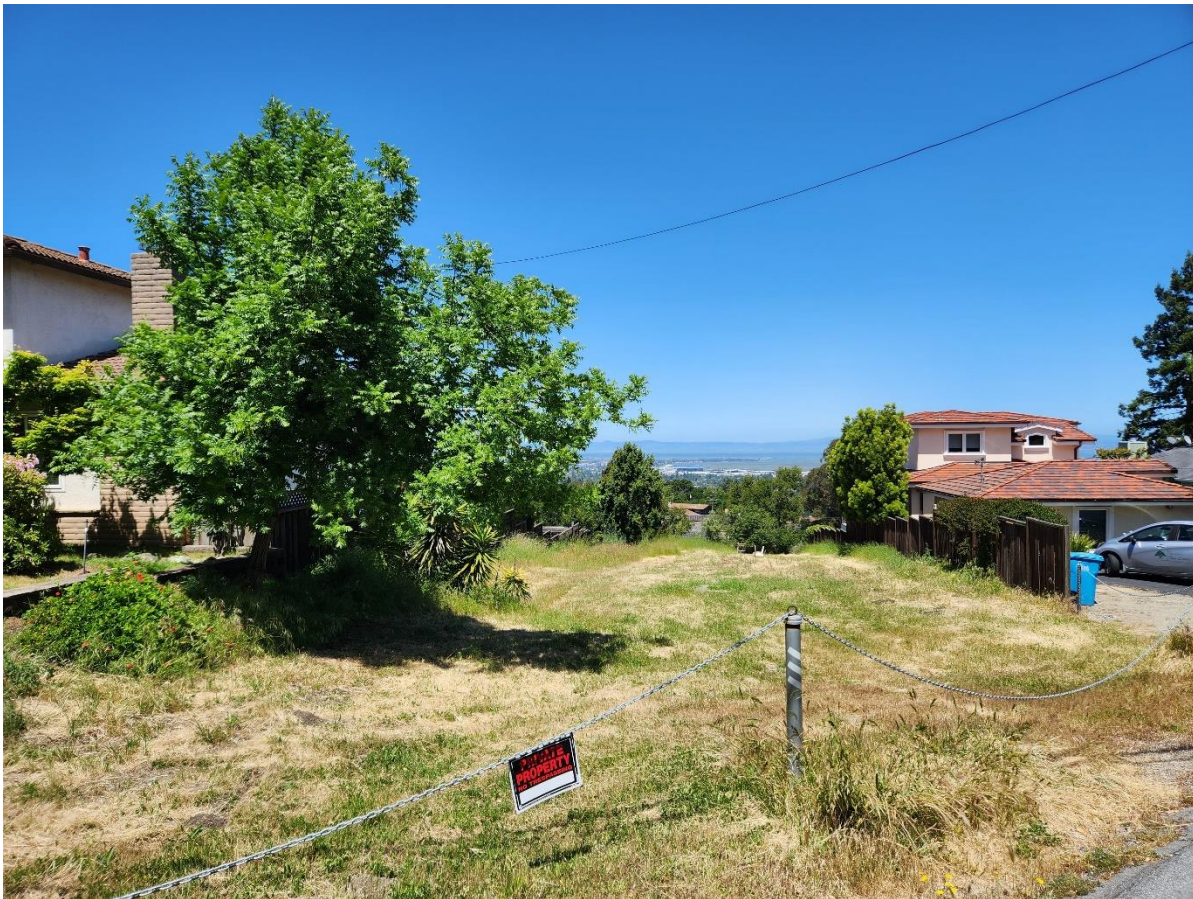
Figure 1. The existing home on the eastern side of the property (right side of image) is proposed to be demolished. Tree #271 (left) is only 2' from the proposed parking area and is proposed to be removed.

Two additional trees, #271-272, are within 2' of the proposed hardscape (figures 1-2). At this distance, I expect large structural roots to conflict with hardscape installation. These roots are responsible for anchoring a tree in the soil, so damaging them not only impacts overall tree health, but can jeopardize whole tree stability.

Typical hardscape preparation requires excavation into the existing grade and sometimes necessitates soil compaction. Per email communication with Design Engineer Waleed Alzori, excavation for the overflow parking area near tree #271 will likely be a minimum of 21", which would conflict with most tree roots in that portion of the tree's root system. Moreover, tree #271 is a black walnut, a species which is intolerant of root loss. This tree is likely to decline following the proposed excavation for the parking and walkway, as well as the proposed grading up to the trunk. To retain the walnut, significant design changes would be needed including minimizing grade changes and relocating the parking area further from the tree.

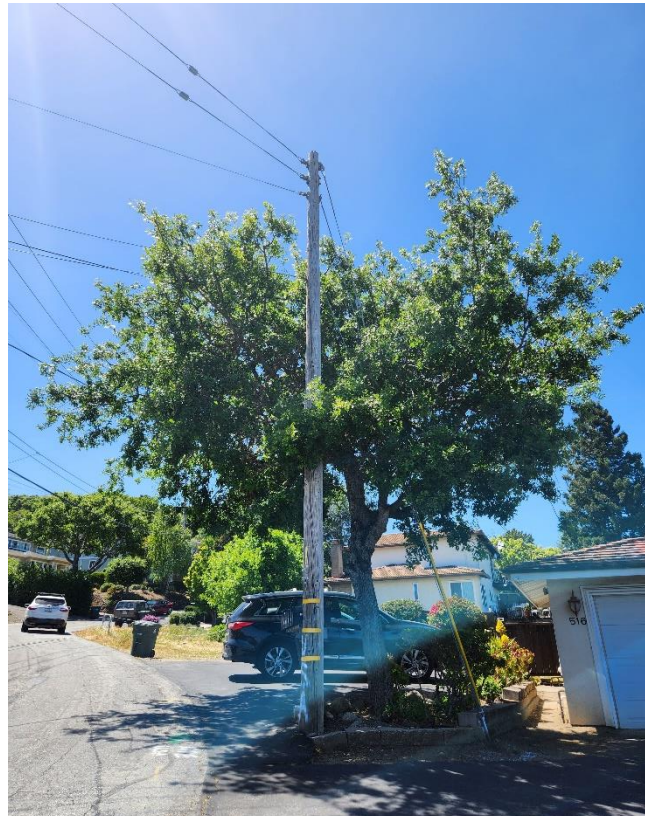
Figure 2. Large structural roots will likely conflict with the proposed driveway, so tree #272 is proposed to be removed.

Similarly, to retain tree #272, the driveway would need to either be shifted further from the tree or it would need to work around large structural roots. This would also require the project arborist be on-site to monitor demolition and excavation work adjacent to the tree. Removing trees #271-272 is the most cost-effective approach to constructing the desired driveway and parking layout.

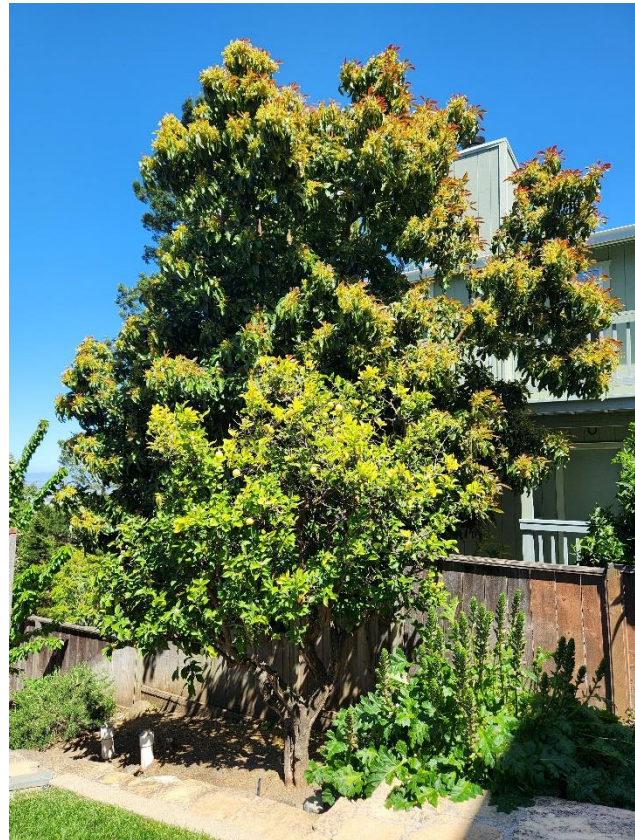
The neighbor's avocado (figure 3) was not surveyed, so distances from the proposed improvements are approximate. The tree is 4' from the proposed walkway and electrical conduit as well as 6' from the proposed sanitary sewer line. Moreover, it is roughly 1' from the new property line fence, which is proposed to align with the actual property boundary. There is a possibility that large structural roots could conflict with these improvements.

Figure 3. Proposed improvements will likely encroach on the avocado's structural roots (large tree in back of image). The project arborist shall be called on-site to monitor work within 10' of the trunk. Tree #277 (small tree in front of image) will be removed to accommodate the proposed walkway.

To minimize damage to tree roots, I recommend the project arborist be called on-site to monitor all ground-disturbing work within 10' of the trunk. This includes demolition of the existing walkway, boulders, and property line fence as well as excavation and trenching. The project arborist may recommend that some digging be performed by hand or with an air excavation device, a tool which uses compressed air to dislodge soil without harming tree roots. If large roots conflict with the proposed improvements and adjustments cannot be made to accommodate them, the project arborist may recommend the tree be removed. Removal will require permission from the neighbor.

As discussed in the previous section, contractors shall install temporary protection fencing between the existing property line fence and retaining wall to keep construction-related activities away from tree roots and soil. If the fencing will hinder construction access, contractors shall discuss alternatives with the project arborist. Two alternatives are to apply a 6" thick layer of mulch with 3/4" plywood on top OR use steel plates.
