May 29, 2024

Re: Arborist Report for 516 Lakemead Way, Emerald Hills

TREE PROTECTION PLAN

for 516 Lakemead Way

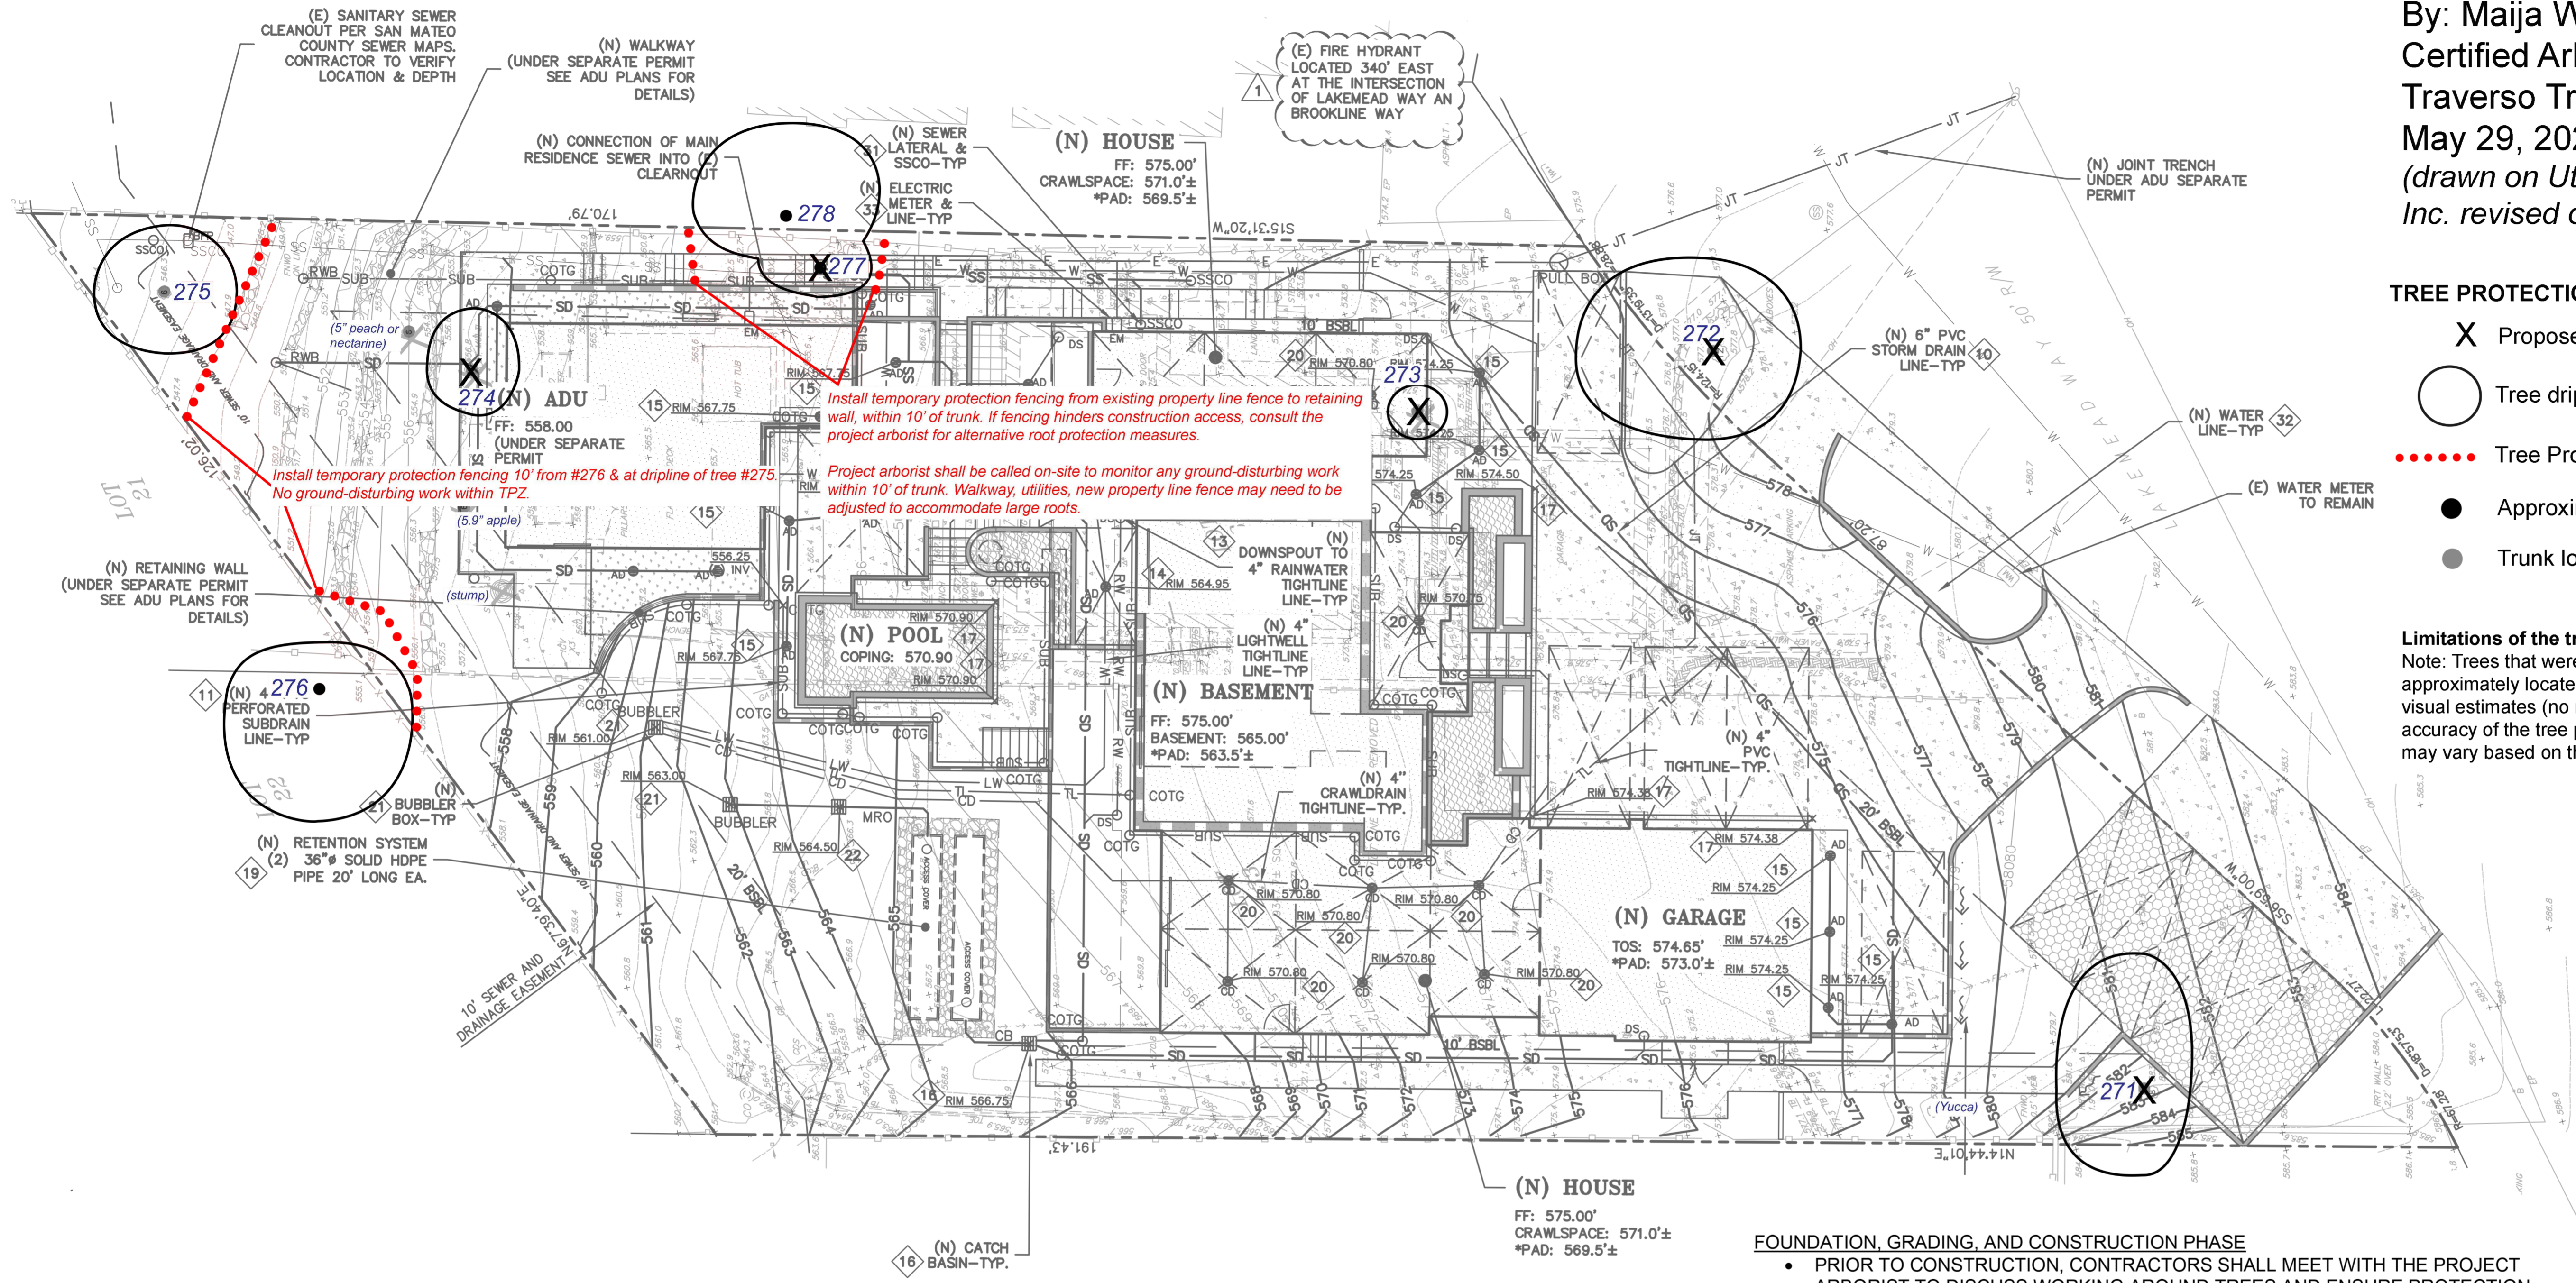
TREE PROTECTION RECOMMENDATIONS

Note: Trees that were not surveyed were approximately located by the arborist using visual estimates (no measurements or GPS); accuracy of the tree protection recommendations may vary based on the location accuracy.

- PRIOR TO CONSTRUCTION, CONTRACTORS SHALL MEET WITH THE PROJECT ARBORIST TO DISCUSS WORKING AROUND TREES AND ENSURE PROTECTION MEASURES ARE IN PLACE.
- THE PROJECT ARBORIST SHALL BE CALLED ON-SITE TO MONITOR EXCAVATION/GRADING WITHIN 10' OF TREE #278. IF APPROPRIATE, ROOTS SHALL BE CLEANLY PRUNED WITH A HANDSAW OR SAWZALL, IMMEDIATELY COVERED, AND KEPT MOIST TILL BACKFILLED.

- SHOULD TREE PROTECTION ZONE (TPZ) ENCROACHMENT BE NECESSARY, THE CONTRACTOR SHALL CONTACT THE PROJECT ARBORIST FOR CONSULTATION AND RECOMMENDATIONS.
- CONTRACTOR SHALL KEEP TPZS FREE OF ALL CONSTRUCTION-RELATED MATERIALS, DEBRIS, FILL SOIL, EQUIPMENT, ETC. THE ONLY ACCEPTABLE MATERIAL IS MULCH SPREAD OUT BENEATH THE TREES.

- SHOULD ANY DAMAGE TO THE TREES OCCUR, THE CONTRACTOR SHALL PROMPTLY NOTIFY THE PROJECT ARBORIST TO APPROPRIATELY MITIGATE THE DAMAGE.
