**COUNTY OF SAN MATEO
PLANNING AND BUILDING DEPARTMENT**

SUBJECT: EXECUTIVE SUMMARY: Consideration of a Design Review and Coastal Development Permit to construct a new ~~2,763~~ 2,798 sq. ft. two-story single-family residence with attached ~~474~~ 464 sq. ft. garage on a 6,210 sq. ft. parcel and right-of-way improvements to allow for emergency vehicle access. The project involves 120 cubic yards of grading for site improvements and no trees have been proposed for removal.

County File Number: PLN 2019-00229 (Deac)

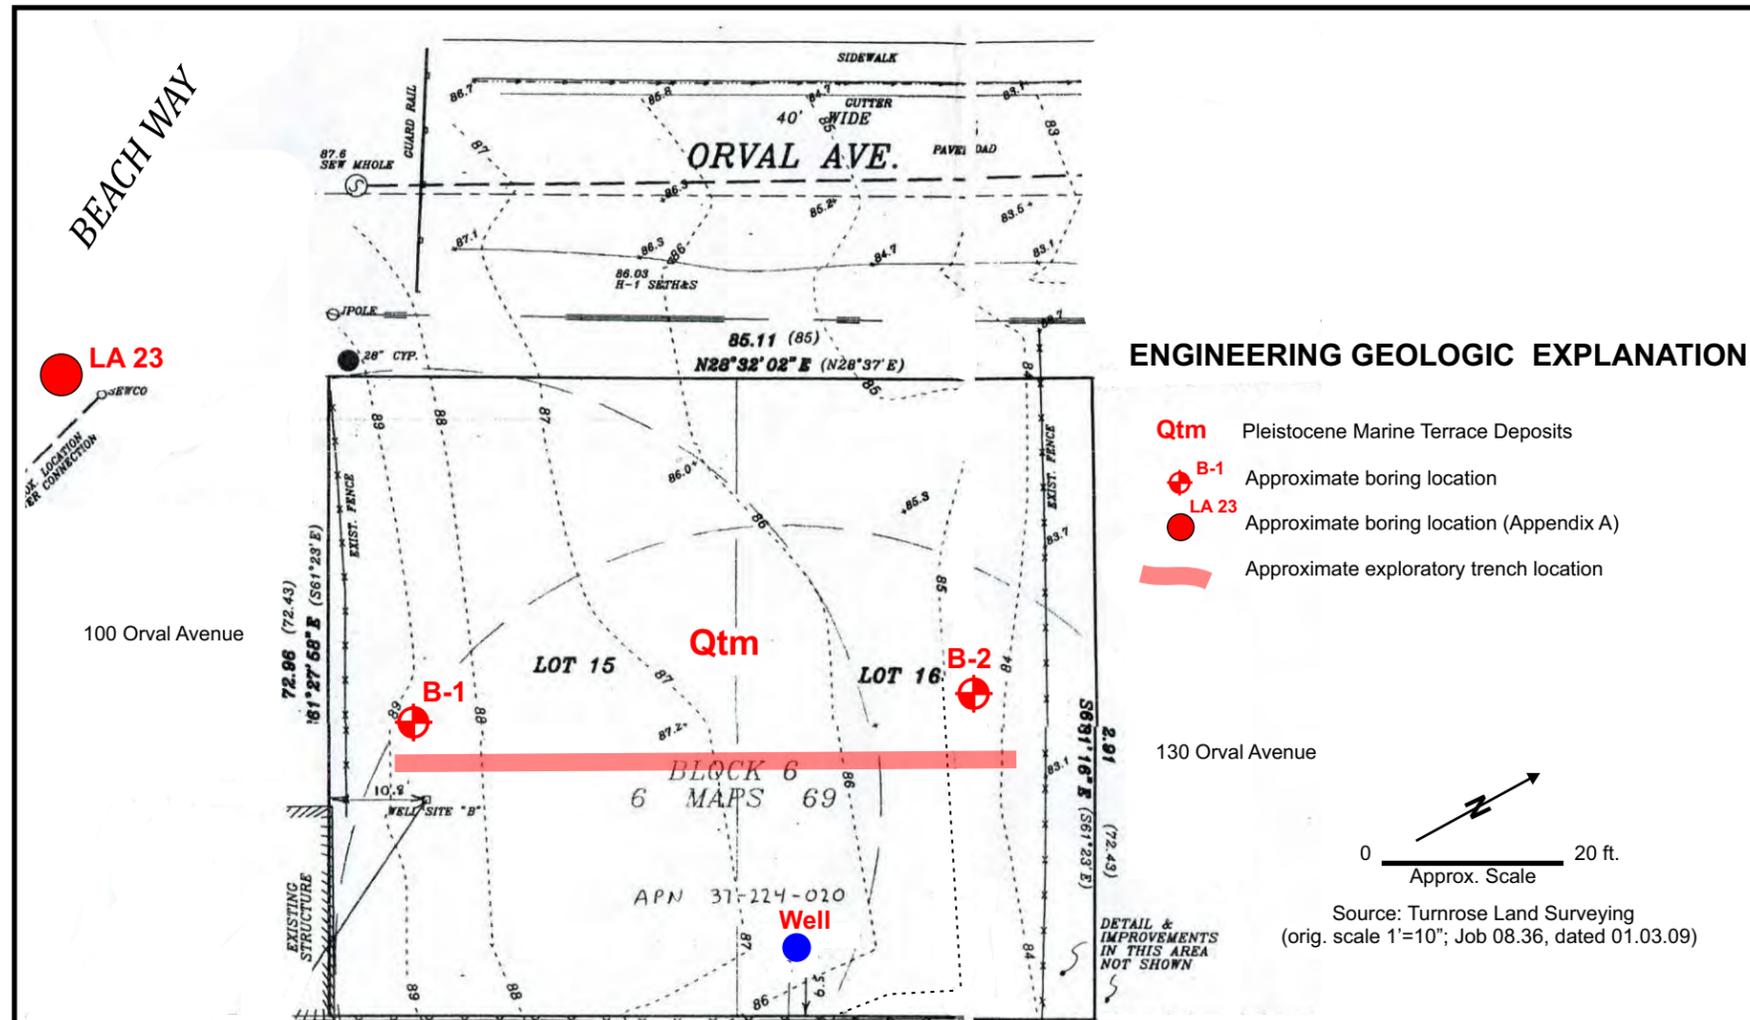
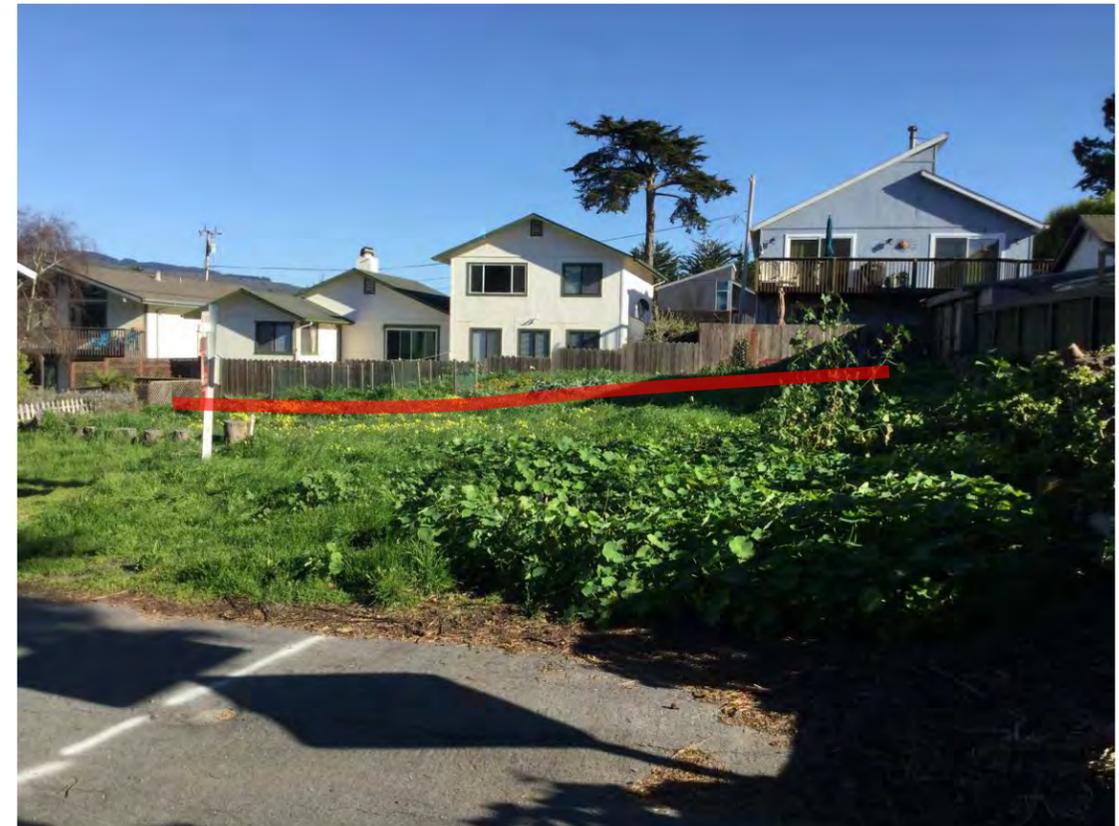
Engineering Geologic Map

Photo 1. Southeasterly view across site from Orval Avenue. Exploratory trench excavated 5' to 6' deep into tilled ground surface that ascends approximately 6 feet from north (left) to south (right). Homes in distance are on Los Banos Avenue.

- Continuous sampling of the Site soil profile at two locations on January 21, 2018 using portable sampling equipment (Plate 2, Engineering Geologic Map, Log of Exploratory Trench and Photo 1). Relatively undisturbed samples to a depth of 9½ were retrieved by driving California, modified California and Standard Penetration (SPT) split-spoon samplers with a 140-pound hammer lifted to a height of 30 inches using a rope and cathead lift mechanism mounted to a tripod. The number of free-fall drops (blows) required to advance the respective samplers at 6-inch intervals for a total of 18 inches driven were recorded. The blows required to advance the final two 6-inch intervals, for a total of 12 inches, are representative of the soil strength, and were converted to Standard Penetration Test (SPT) values. Blow counts from driving the modified California and California sampler were converted to Standard Penetration Test values using a multiplier of 0.76 and 0.93, respectively. The Logs of Borings are presented on Plate F1 and the Key to Borings on Plate F2 (Appendix F).

- Geologic logging of an exploratory trench approximately on February 2, 2018, to evaluate for subsurface evidence of deformation from landslide or fault. The exploratory trench was 68 feet long by approximately 6 feet deep. The trench location and log is presented on Plate 2.

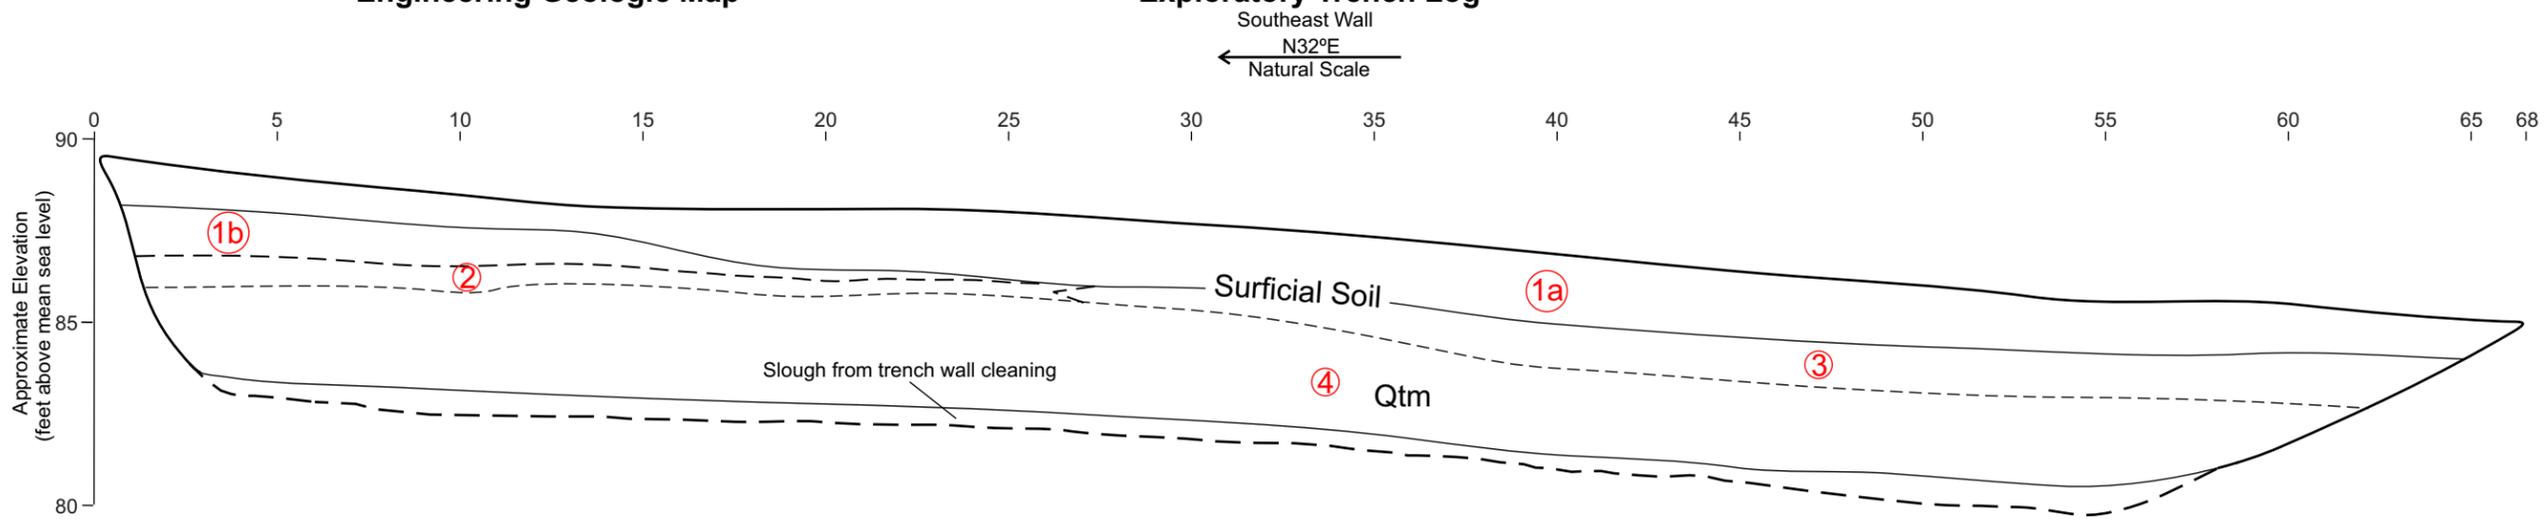
Exploratory Trench Log

- SOIL UNITS**
- 1a. Silty, sandy clay with gravel; black, moist to damp, very porous, turbated, some fine roots, turbated; occasional trash (af)
 - 1b. Same as 1a without trash (Topsoil)
 2. Silty sandy clay; dark brown, wet, firm to stiff, very plastic, dessication cracks (cambic horizon)
 3. Sandy clay with occasional angular lithic clasts to 1"; gray and strong brown mottled, damp, stiff, very plastic (Residual Soil)
 4. Clayey fine-to medium-grained sand with coarse sand-size clasts of decomposed feldspar, damp, medium dense, common diffuse vertical gray and strong brown striations (Pleistocene Marine Terrace Deposits)

A thin, very plastic, cambic soil horizon was encountered between the topsoil and residual soil at the top of the terrace deposits extending to the bottom of the trench. Ground water was not encountered in the explorations. Relative soil moisture was generally damp.

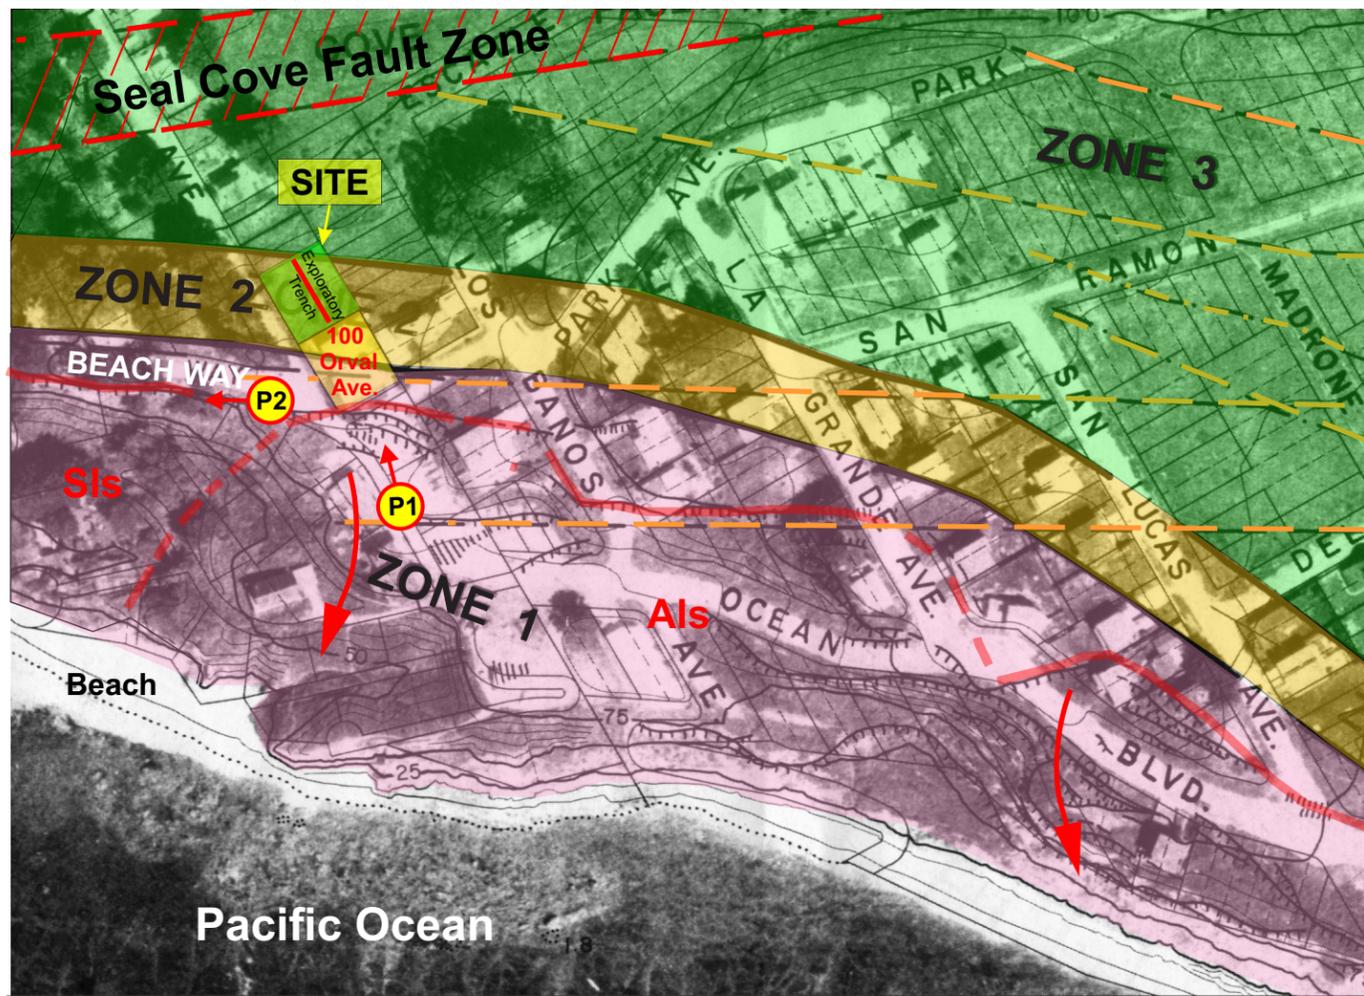
GEOLOGIC HAZARDS MAP

- Als** Active Landslide
- Sls** Belt of coalescent deep scaled Landslide (stabilized in the early 1980's)
- Exploratory Trench (this study)
- Scarp
- Trench
- Depression
- Tension Crack
- Faults by Leighton and Associates (1971)
- Faults-related features compiled from aerial photographs
- ZONE 2** Geotechnical Hazard Zone Boundary: where **ZONE 1** indicates unstable; **ZONE 2** indicates questionable stability; **ZONE 3** indicates most stable
- ZONE 1**
- P1** Line of sight for Photo 1
- Arcuate belt of Active Landsliding; solid where inferred from surface deformation dotted where uncertain

arcuate belt along the western margin of the Seal Cove between Madrone Avenue and Alton Avenue and extending up to 400 feet inland of the seacliff. The entire segment of seacliff is subjected to shallow landslides from the top of seacliff, and recession by erosion of the exposed cliff face (Plate 4). The most active movement over the past 30+ years seems to have occurred in the southern part of the belt, between Los Banos Avenue and San Lucas Avenue, where at least 3 homes have been removed. Much of northern Ocean Boulevard and western Los Banos Avenue have become impassible since the early 1990's. The mode of erosion south of San Lucas Avenue is shallow soil slumps and avalanches from the oversteepened terrace deposits underlying the top of the seacliff.

- Appendices B and C indicate the Site is approximately 80 feet from the middle part of an arcuate belt of active, deep-seated bedrock landsliding affecting the western side of Seal Cove between Madrone and Los Banos Avenues for an inland distance of up to 400 feet (Plate 4). Over the past 30 years of periodic observation of relative rate and magnitude of scarp development, and distribution of landslide surface deformation, we infer the belt is represented by possibly 4 coalescent landslides with differing rates of movement.

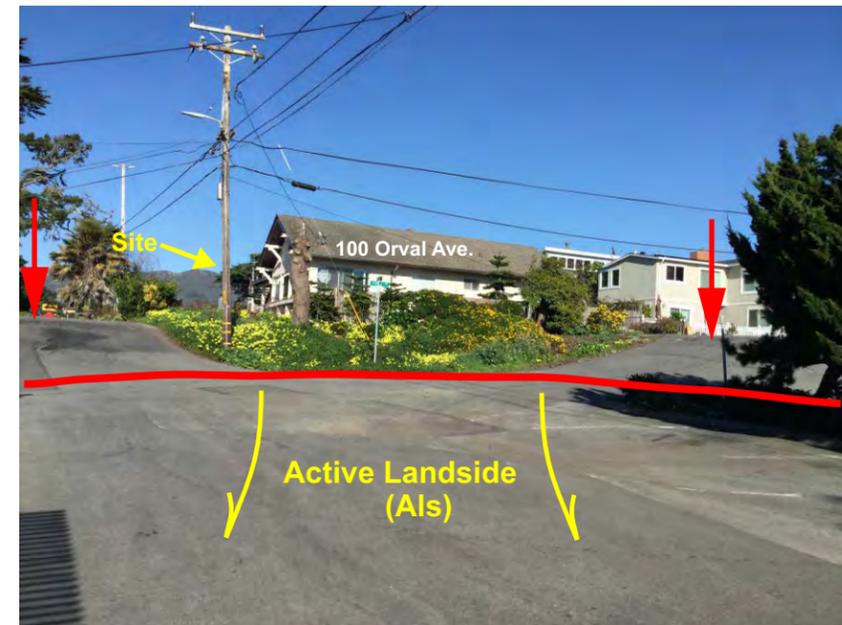
P1. North view from Distillery Restaurant across middle part of active landslide belt. Headscarp of Als defined by rise in roadway between red line and arrows has retreated several feet to the southern perimeter of 101 Orval Ave. without visibly affecting the structure. Site in distance is approximately 80 feet from the headscarp. The upper left arrow correlates with the projection of the southern part of the active landslide belt.

The middle part of the landslide belt, between Los Banos Avenue and Orval Avenue and involving the Distillery Restaurant and at least 3 adjacent homes, continues to move, but geotechnical survey monitoring between 1975 and 2016 (10 year gap between 1986 and 1996) indicates movement in the headward northern flank of the middle landslide area has subsided over the past 10 years (Appendix D). While the height of a distinct headscarp marking the landward limit of the middle landslide area has increased, it does not appear to have receded inland more than up to several feet over the past 30 years (Plate 4, Photo 2).

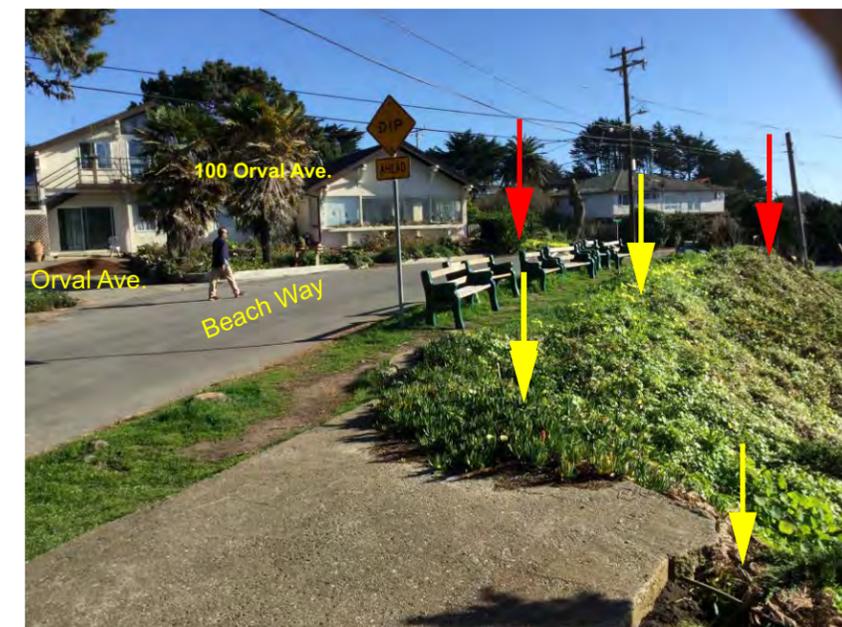
P2. Northwestern view along crown of headscarp (yellow arrows) located approximately 80 feet from the site out of view to the left. Northward projection of active landslide scarp (red arrows) in P1 intersects the up to 40-foot high scarp of the stabilized landslide at the intersection of Orval Avenue and Beach Way, approximately 80 feet west of the site. The presence of the remnant of concrete sidewalk from early 1900 construction combined with mapping on the adjoining hazard mapping indicates the scarp recession has been relatively minor.

The northern part of the landslide belt is characterized by a near-vertical headscarp, up to approximately 40 feet high, extending adjacent to Beach Way right-of-way. It is associated with a former active landslide stabilized in the early 1980's with deep stitch piers and subdrainage (Plate 4, Photo 2; Cross Section D-D' in Appendix A). We did not detect from recent reconnaissance observations notable recession of the densely vegetated scarp, and the early 1900's concrete sidewalk remnant at the top of the scarp indicates relatively static conditions have prevailed over the past several decades. Headscarp-parallel tension cracks, generally representative of scarp retreat of landslide retrogression, were not observed.

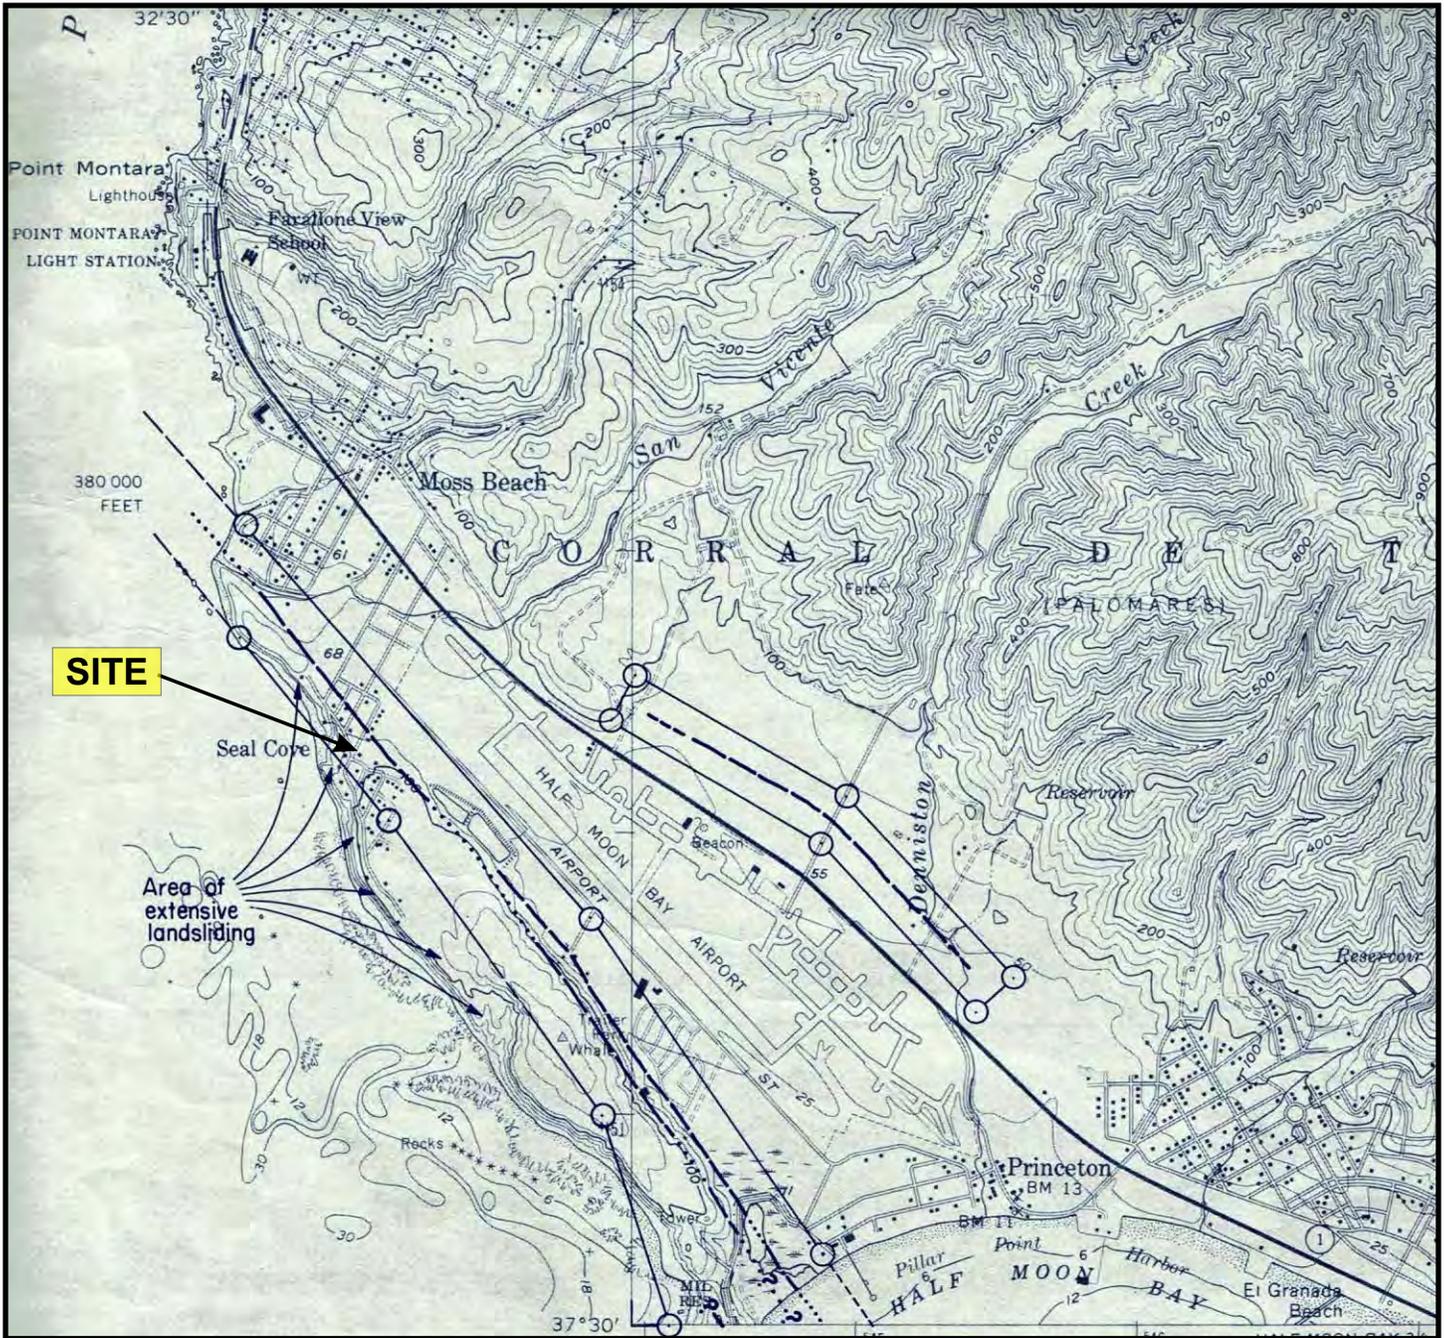
Faults considered to have been active during Holocene time and to have a relatively high potential for surface rupture; solid line where accurately located, long dash where approx. located, short dash where inferred, dotted where concealed; query (?) indicates additional uncertainty. Evidence of historic offset indicated by year of earthquake-associated event or C for displacement caused by creep or possible creep.

The Site occupies Zone 2 of the State of California Earthquake Fault Zone bounding the mapped trace of the active Seal Cove Fault which is mapped approximately 200 feet to the east (Plate 5, Fault Zone Map). The Site is located

- The original designation for the location of the active trace of the Seal Cove Fault has been the near the base of the steep escarpment extending between Pilar Point and Fitzgerald Marine Reserve, and approximately 200 feet east of the Site (Plate 5). Appendix E, however, contains recent, albeit small-scale, mapping of a relatively strong arcuate bend in the active fault trace that would seem to move it closer to the Site. With the generally-accepted assumption that future fault rupture coincides with the trace(s) of pre-existing active fault rupture, coupled with the absence of geomorphic and stratigraphic evidence of fault rupture on the Site from this study, it our opinion the risk is low for occurrence of ground rupture on the Site during a nearby major earthquake

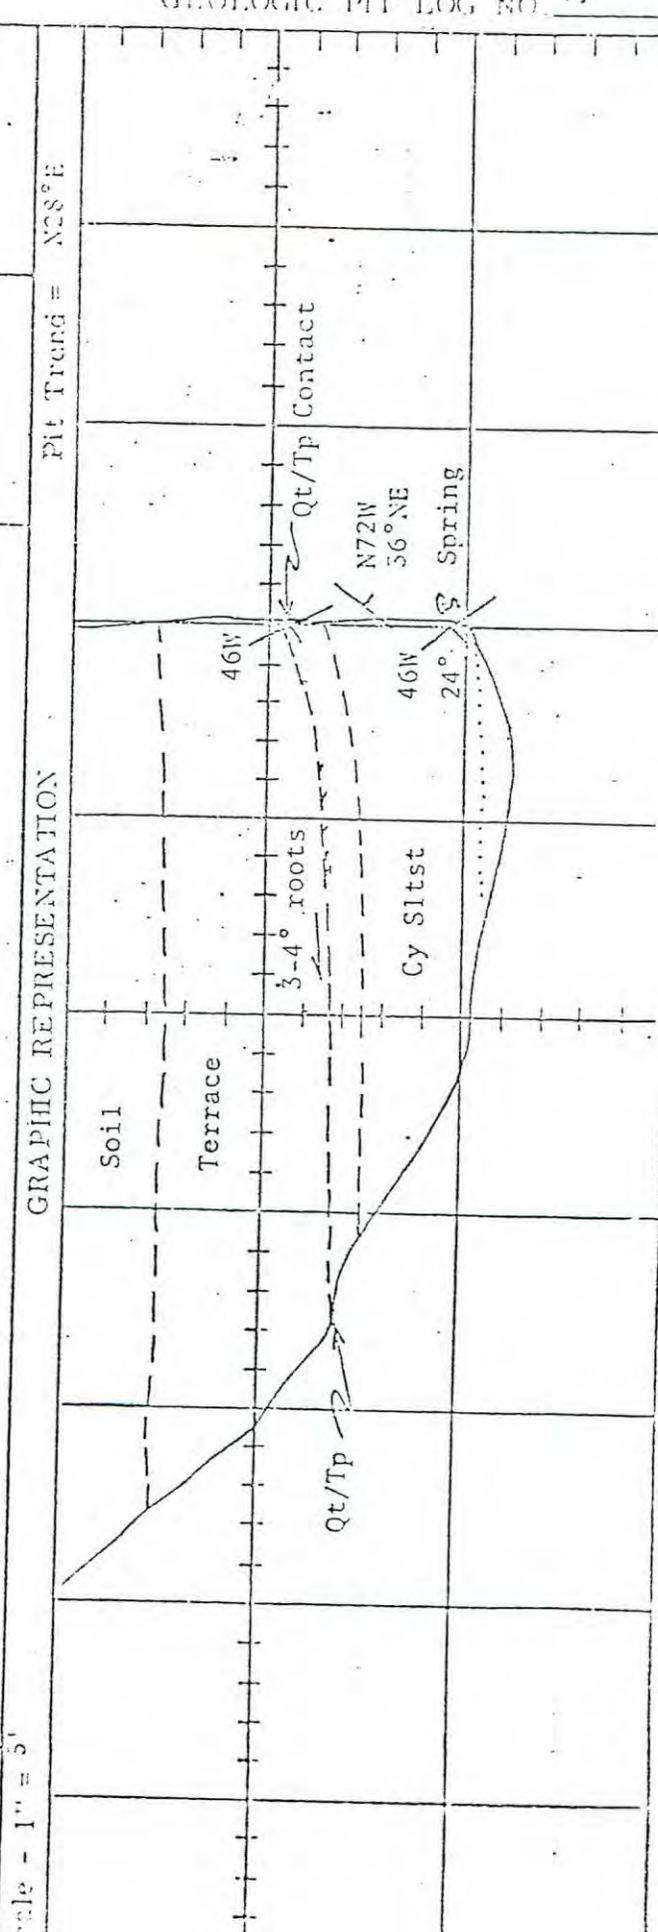
ALTITUDES	ENGINEERING GEOLOGY DESCRIPTION	PHYSICAL CONDITION	COMMENTS
R5 77W, d75°W	Soil: Dk. brn., silty, w/scat. pebbles, root hairs.	Soft Dry in upper 12" Damp below 12"	Ruikure Surface in Qt. is well-developed and loose soil has fill in where a crack formerly existed.
R5 S, d35°W	Qt: Reddish brn.-yl-brn., crs. sd w/clayey mtx. Brown soil along fracture	Firm, Damp	NATURAL SLOPE
R5 7-55W, d67°			Lot pad slopes 2-4° Break in slope 3 fract is 10-15°

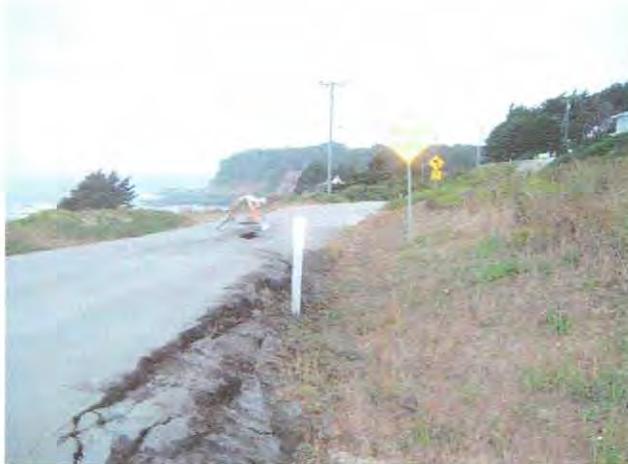
The southern end of the recent activity appears to be near the intersection of Ocean Blvd and San Lucas Avenue. This view is from that intersection, looking northward.

The graben extends into the field to the right, where there are several discontinuous parallel linear depressions in the head scarp area.

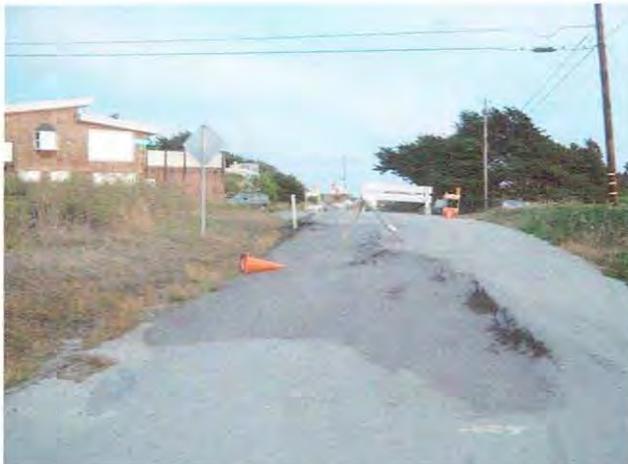
The depression shown here is the graben along the top of the rotating slide mass. The picture was taken facing southward, and the white barrier is at the intersection of Ocean and San Lucas.

The landslide mass is apparently rotating outward as it moves downward. This has caused a graben, or closed depression, to form along the head scarp.

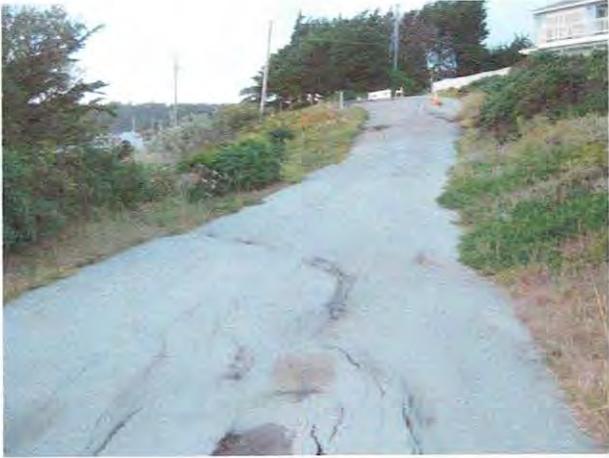
The backscarp formed along the western edge of the graben persists for some distance along Ocean Blvd, gradually leveling out and reversing itself into a normal west-facing scarp.

Downhill of the verge, the scarp is difficult to follow due to the dense vegetation. There is no well-defined landslide toe anywhere in this area.

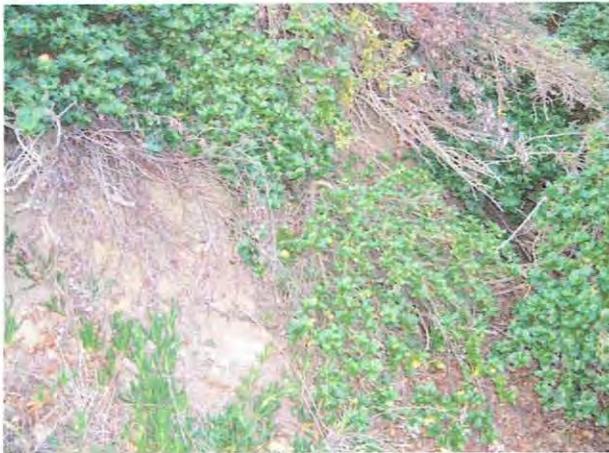
There is a fresh west-facing scarp that runs through this over-steepened portion of the road, and through the vacant lot, just below the light blue house. This scarp shows fresh soil, but its precise extent is impossible to determine due to dense vegetation.

There is water flowing through this vacant lot, close to this scarp. The source of this flow was not determined.

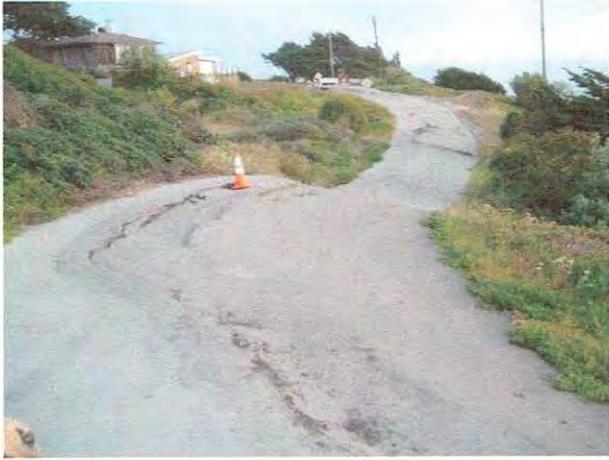
This picture shows Ocean Blvd. from La Grande looking south to San Lucas (see barrier in distance). The road is offset along the cracks by as much as 6" vertically. The angle of dip on the road is from 2 to 20 degrees west.

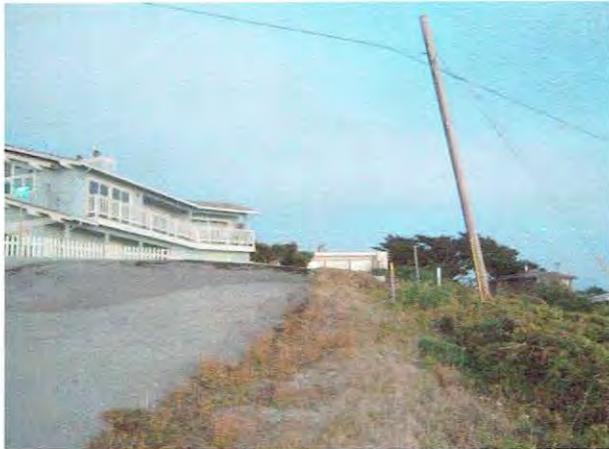
The scarp is visible as a dark wedge on the left of the photo, below the light blue house. The utility pole is one of about six that run along the west side of Ocean Blvd in this area. This is the pole that has been most affected by the movement of the slide. It is in the northern slide, near the scarp.

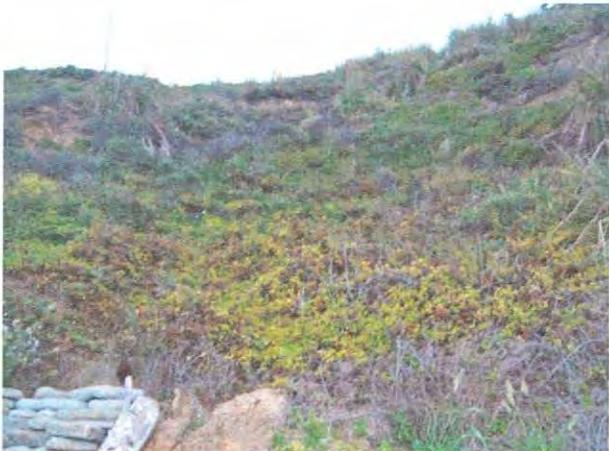
When this area is viewed from below, fresh scarps can be seen in several places, mostly directly below the road. This photo shows the swale immediately downhill of the worst of the recent movement. The leaning pole can be seen faintly in the upper left.

There is no evidence of fresh toe material anywhere in this vicinity on the beach. It appears that the active movement along Ocean Blvd. bottoms out on the natural bench that exists about half way down the slope.

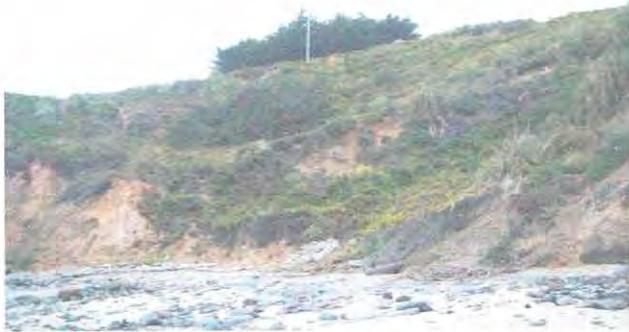
This is another photo showing the swale below the road, but looking slightly more northward than the previous one. The cement “steps” are in the middle at the base of the slope here, for reference. The benched form of the slope is evident, as is the lack of recent movement at the beach level.

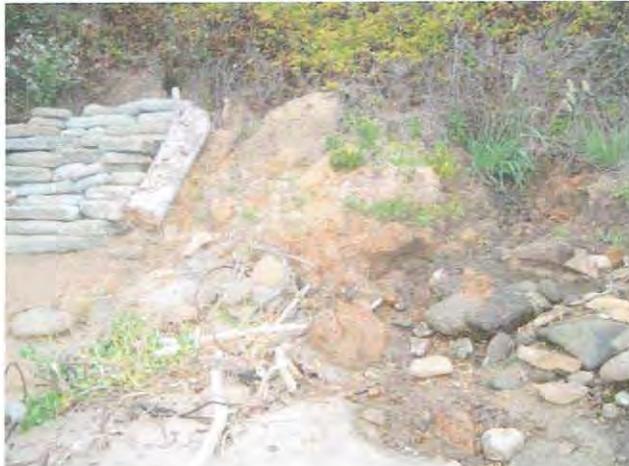
There is a stream coming out at the base of the slope below the distressed portion of Ocean Blvd. On the east side of the road above, there is evidence of uncontrolled drainage coming through the vacant lot. This water may be a contributing factor in the recent movement.

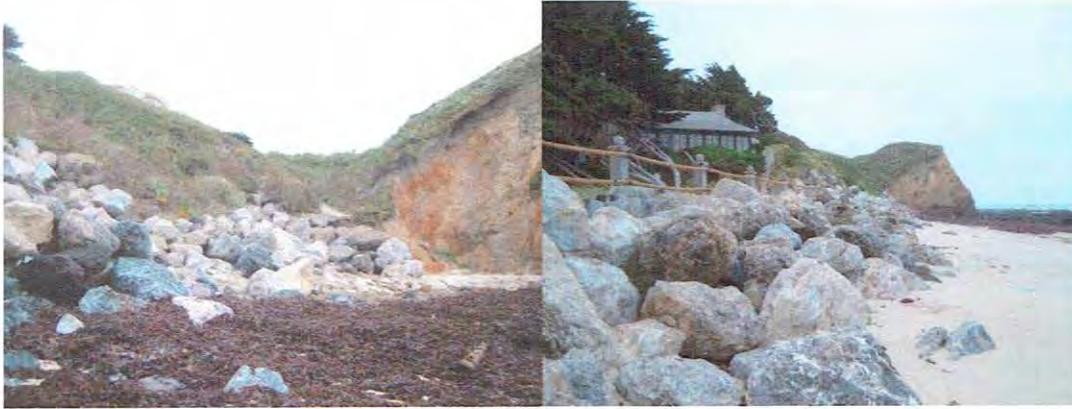
The left photo shows the small cove below the Distillery, which can be seen on the top of the bluff to the left. The picture on the right shows riprap on the beach near one of the houses that sits almost right on the beach. The exposed cliff on the right of the Distillery picture is visible in the distance on the right photo.

There are several generations of riprap and cement cover in the two coves that lie below the area between Madrone Avenue and Cypress St to the north. There are the remains of cement “blankets” on the slope below both of the two remaining houses on the west side of Ocean Blvd. These are the little red house between San Lucas and Madrone (#3 on map 1), and the only occupied home, which is adjacent to the Distillery parking lot (#2 on map 1). The riprap is sparse in places and does not appear to provide much protection for the toe of the slope, particularly below the Distillery. The approximate extent of riprap is shown on map 1.

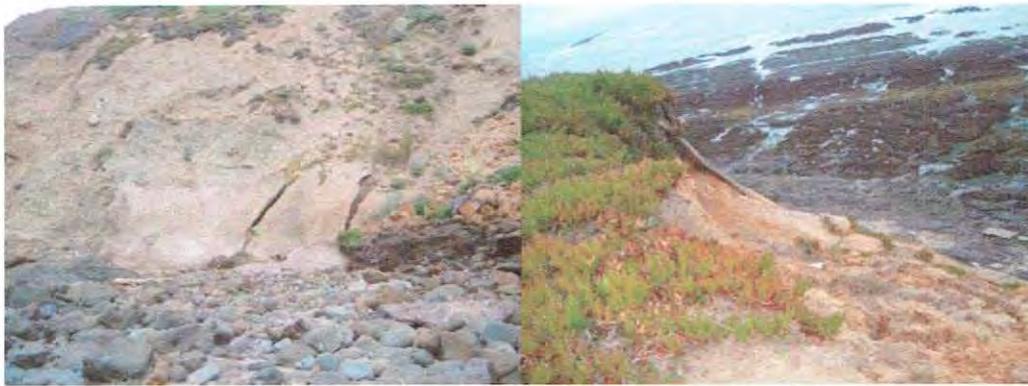
The picture on the left shows part of an old cement “blanket” that sits below the occupied house near the Distillery. It is broken, and the ocean has eroded the rock from behind it. The photo on the right shows the edge (just below the dark green bluff) of another partial blanket of cement that exists downhill of the Ocean Blvd. area that is failing.

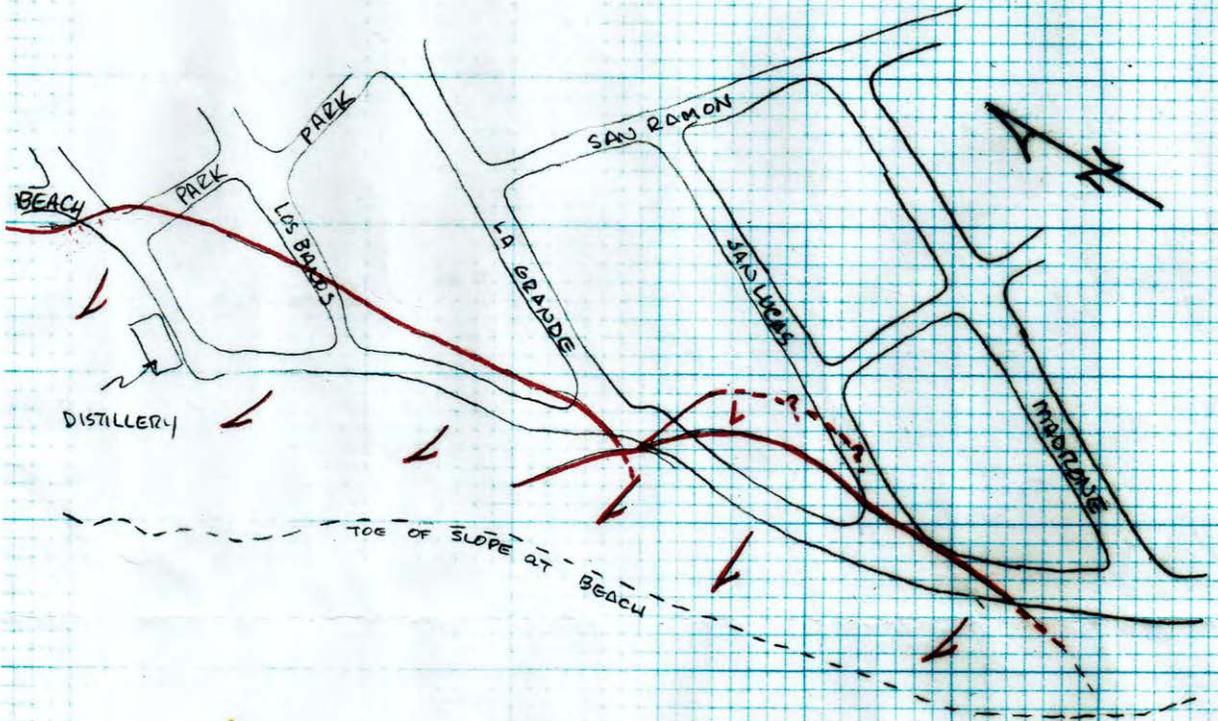
MAP 2
 GENERAL LOCATION
 OF
 ACTIVE LANDSLIDES

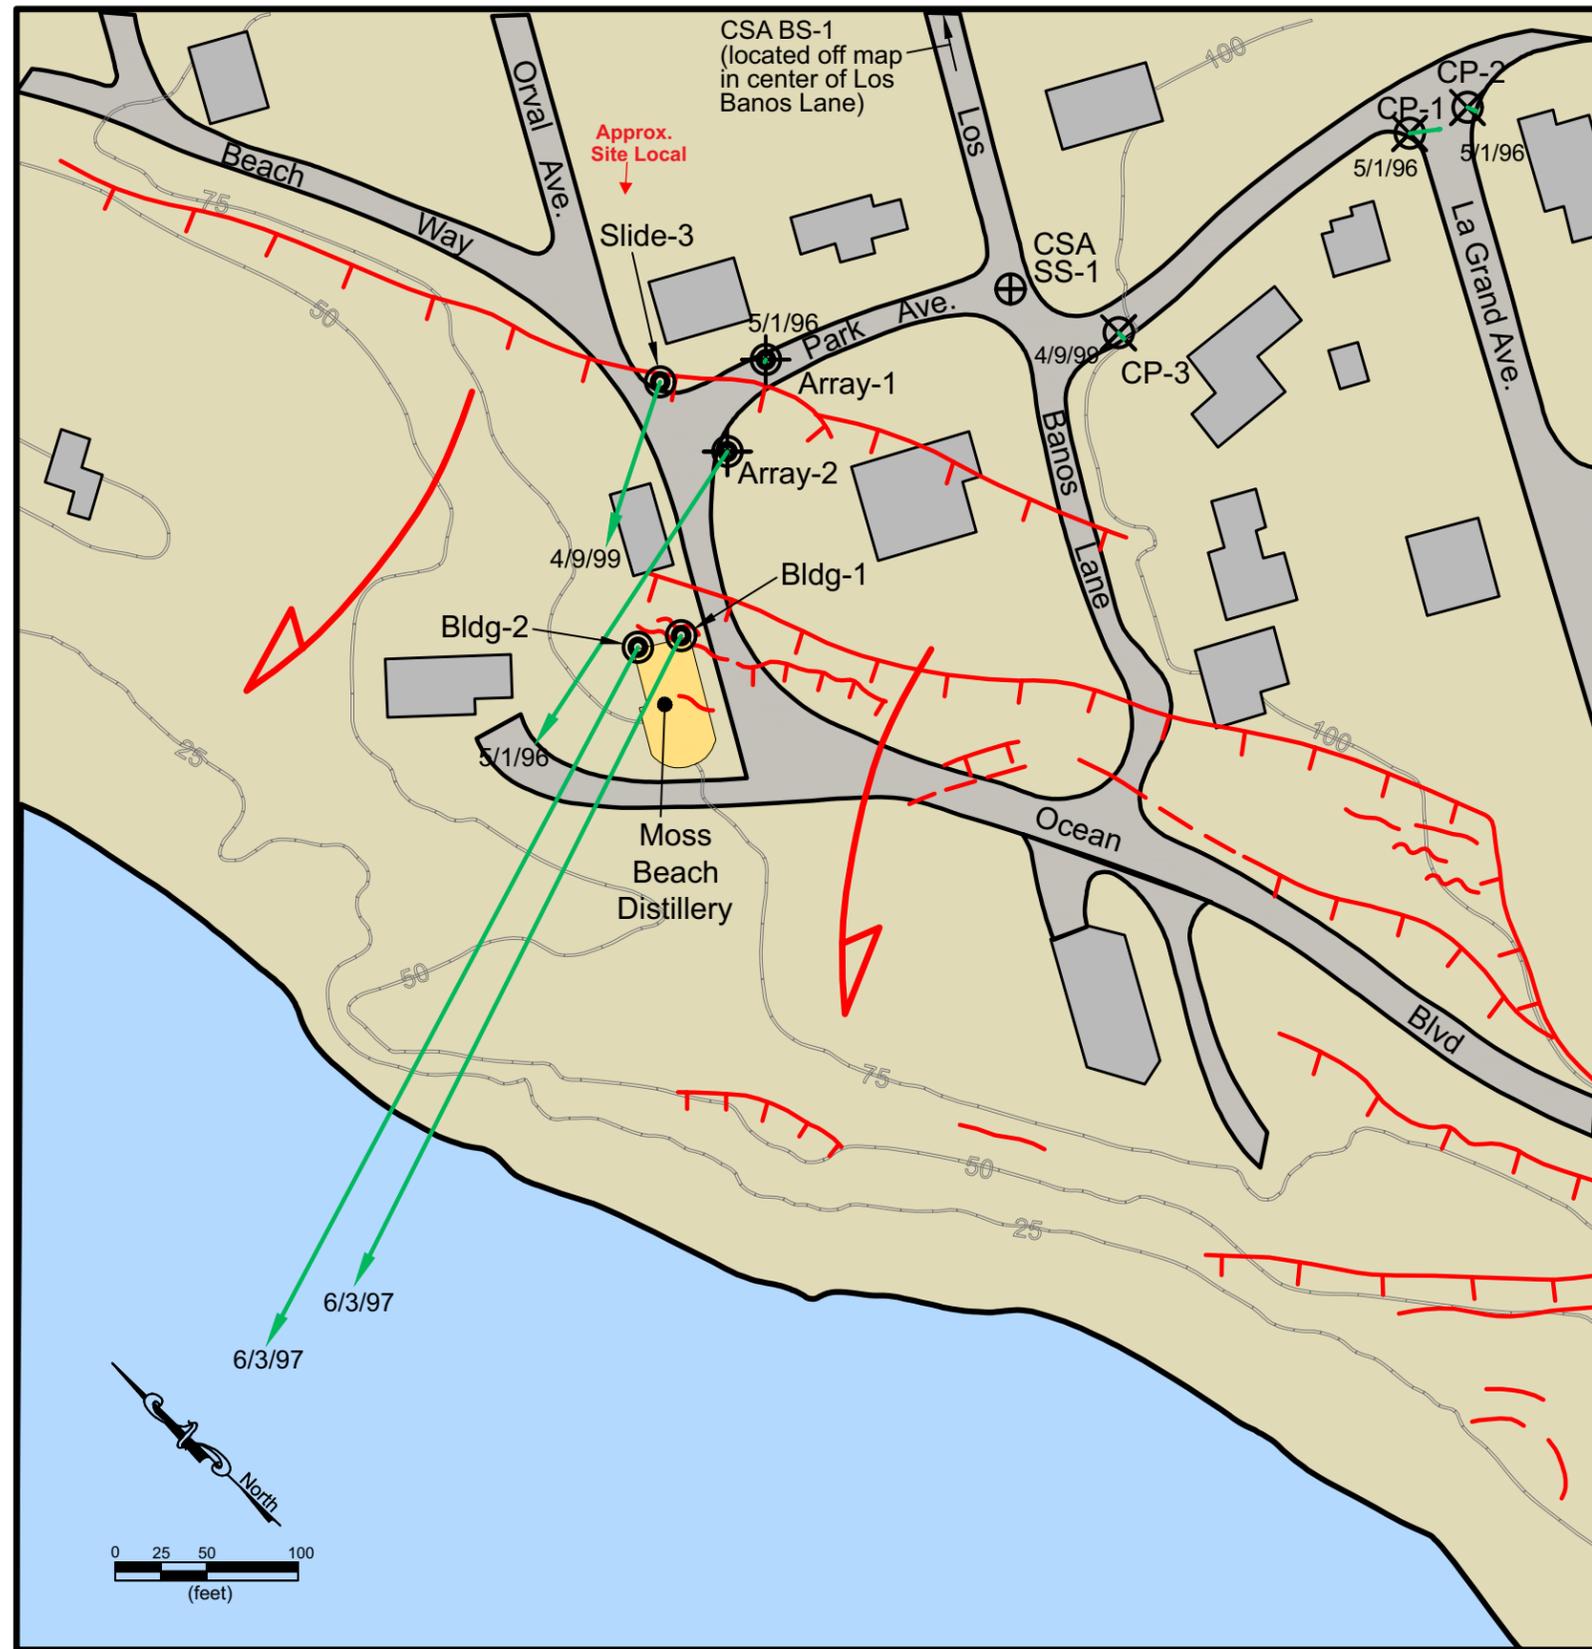
GEO/ENG BY JD	SCALE 1"=100'	PROJECT NO. G3335D
APPROVED BY DRM	DATE November, 2016	FIGURE NO. 1

LANDSLIDE MONITORING PROGRAM
MOSS BEACH DISTILLERY
SAN MATEO COUNTY, CALIFORNIA

As expected, the monument located on the building (Bldg-2) continued to move toward the ocean (see Figure 1), although at a much slower rate than has been observed in the past. The other monument located on the landslide (Array-2) also continues to move toward the ocean, although at a slower rate than Bldg-2. The tape measurement confirmed this movement during the past year, showing displacements towards the ocean of 1.2 inches (Array-1 to Array-2) during the last monitoring period. The survey and tape measurements indicate that the total landslide displacement was approximately 3.3 inches since our previous monitoring visit, in the area of the building, and 1.2 inches in the upper portion of the landslide where the Array-2 monument is located. Since we began surveying the building in 1997, the total horizontal displacement of the building has been approximately 43.1 inches. To compare this year's movement to previous years, the movement measured at survey point Bldg-2 and rainfall have been plotted versus time on Figure 2 (attached). The average horizontal and vertical building movement rates from 2014 to 2016 are 1.4 and -0.9 inch per year, respectively (see Table 1). These annual movement rates are lower than the estimated average long term horizontal and vertical building movement rates of 2.7 and 1.6 inches per year, respectively, as shown on Figure 2. These lower movements are likely the result of relatively lower rainfall amounts over the past year.
