**COUNTY OF SAN MATEO
PLANNING AND BUILDING DEPARTMENT**

SUBJECT: EXECUTIVE SUMMARY: Consideration of a Design Review and Coastal Development Permit to construct a new ~~2,763~~ 2,798 sq. ft. two-story single-family residence with attached ~~474~~ 464 sq. ft. garage on a 6,210 sq. ft. parcel and right-of-way improvements to allow for emergency vehicle access. The project involves 120 cubic yards of grading for site improvements and no trees have been proposed for removal.

County File Number: PLN 2019-00229 (Deac)

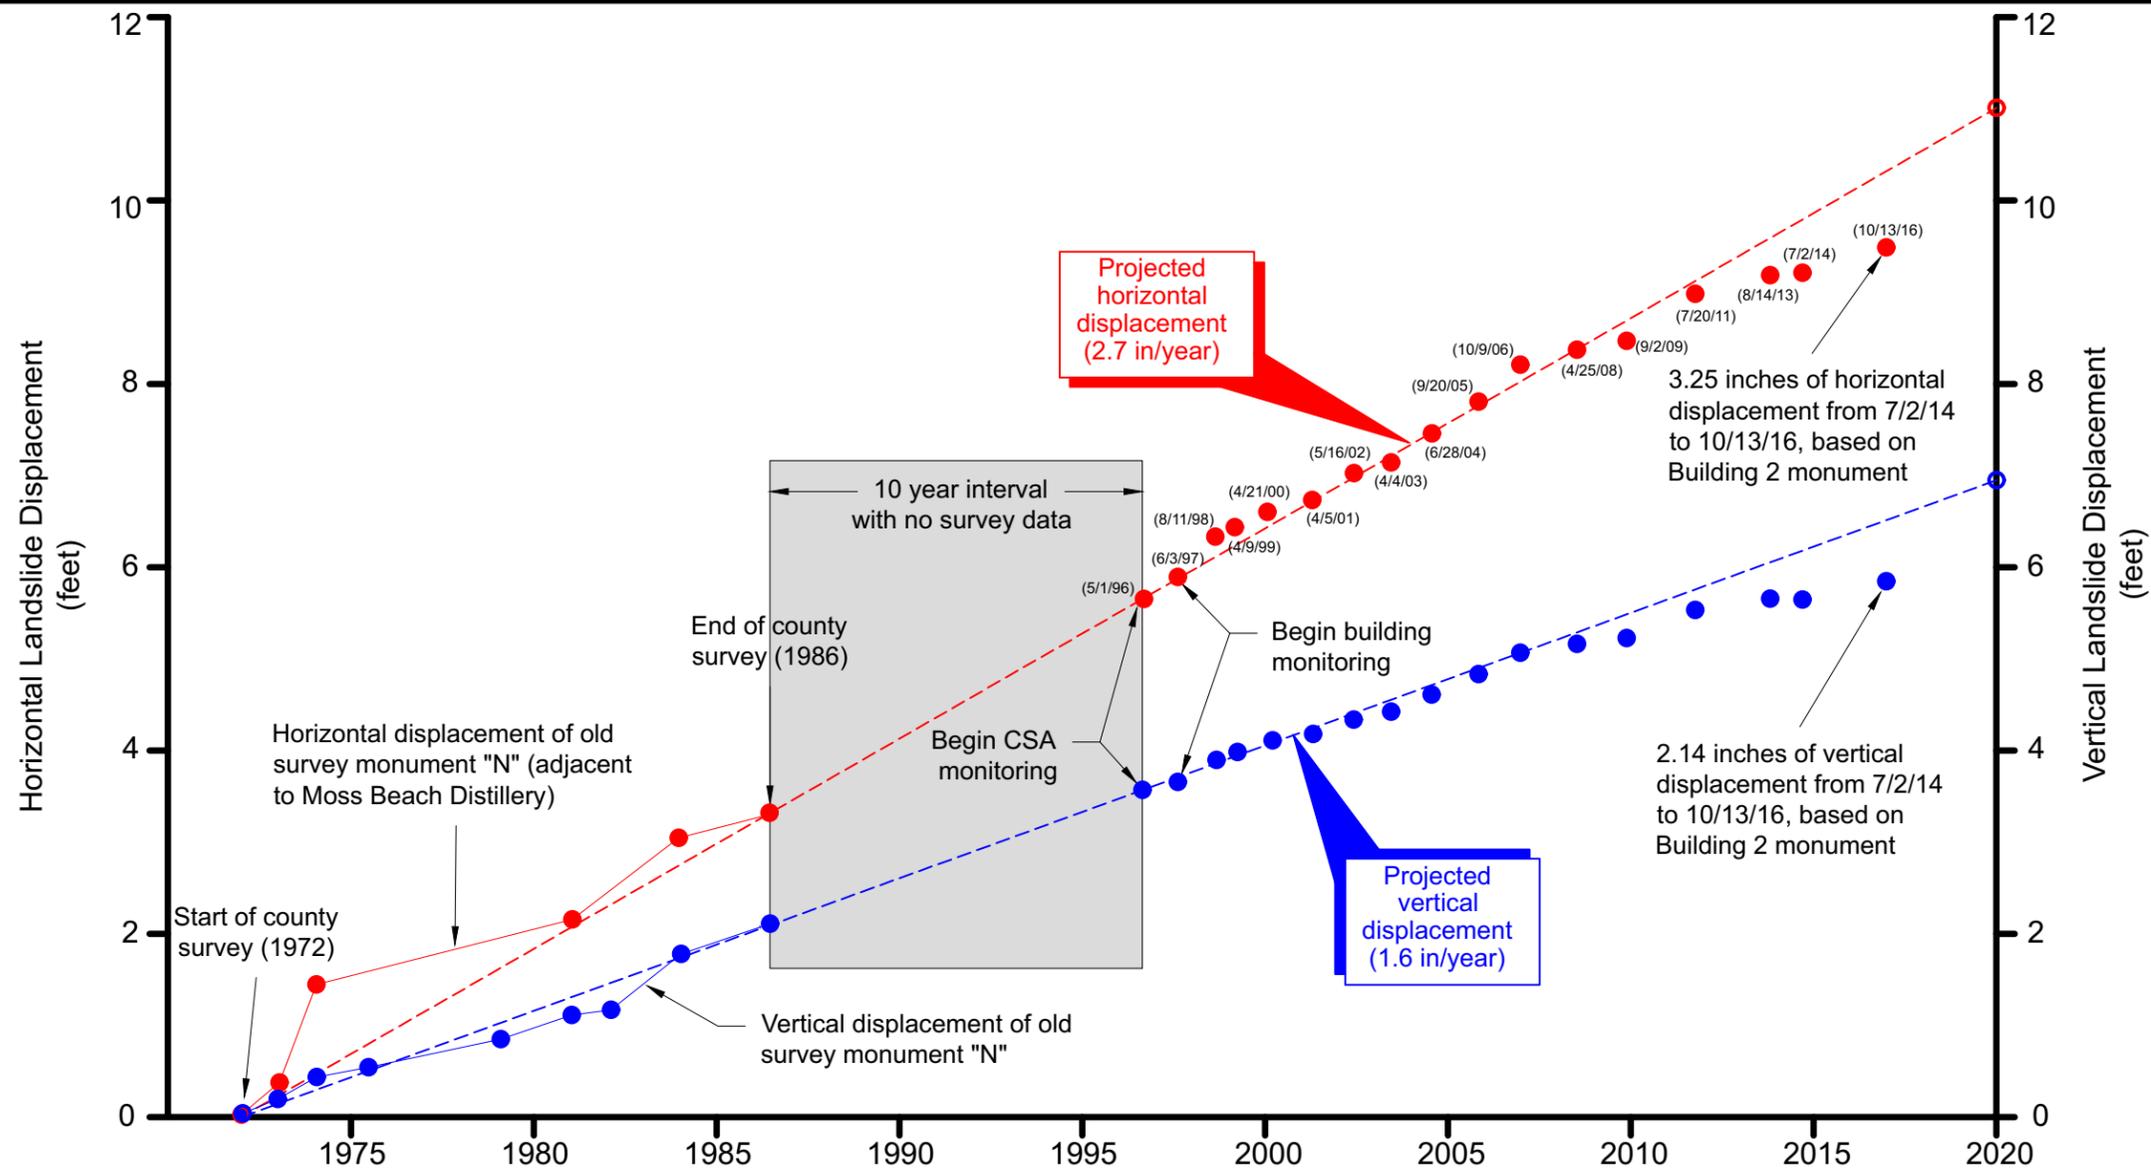
*Data up to 7/2/14 based on average of 2 building monuments

The active landslide under the Moss Beach Distillery continued to move slowly over the past two years, and displaced on average approximately 1.4 inches per year in the horizontal direction, and 0.9 inch per year in the vertical direction (downward). These short term rates are below the average historical movement rates based on previous surveys and the overall displacement is below the historical trend. On the basis of this new survey and the record of historical landslide behavior, we continue to consider the potential for sudden failure of the landslide to be low. We recommend that monitoring of the landslide continue on an annual basis.

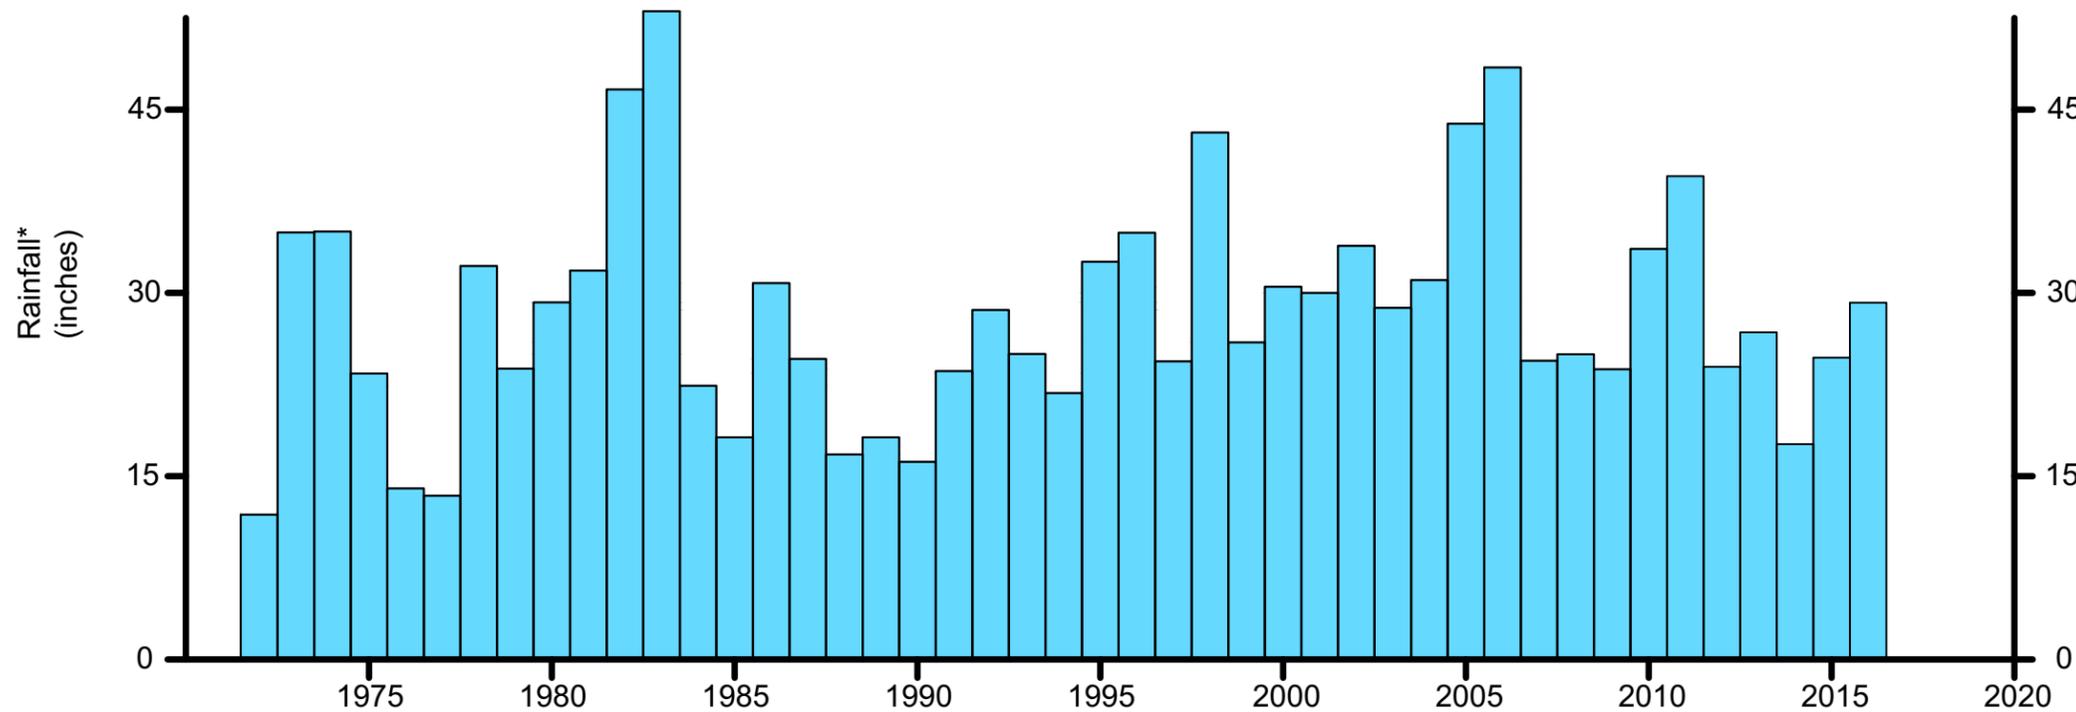
*Rainfall data from 1972 to 2001 collected from the National Climatic Data Center, National Weather Service, and National Oceanic and Atmospheric Administration weather stations:
 Half Moon Bay
 Pacifica 4SSE
 Pacifica 2S
 San Gregorio

*Rainfall data from 2002 to 2016 collected from the Alta Vista Water Treatment and Storage Facility, Montara, California (Lat. N37°32'54.02", Long. W122°29'53.33", NAD27, Elev. 475 feet)

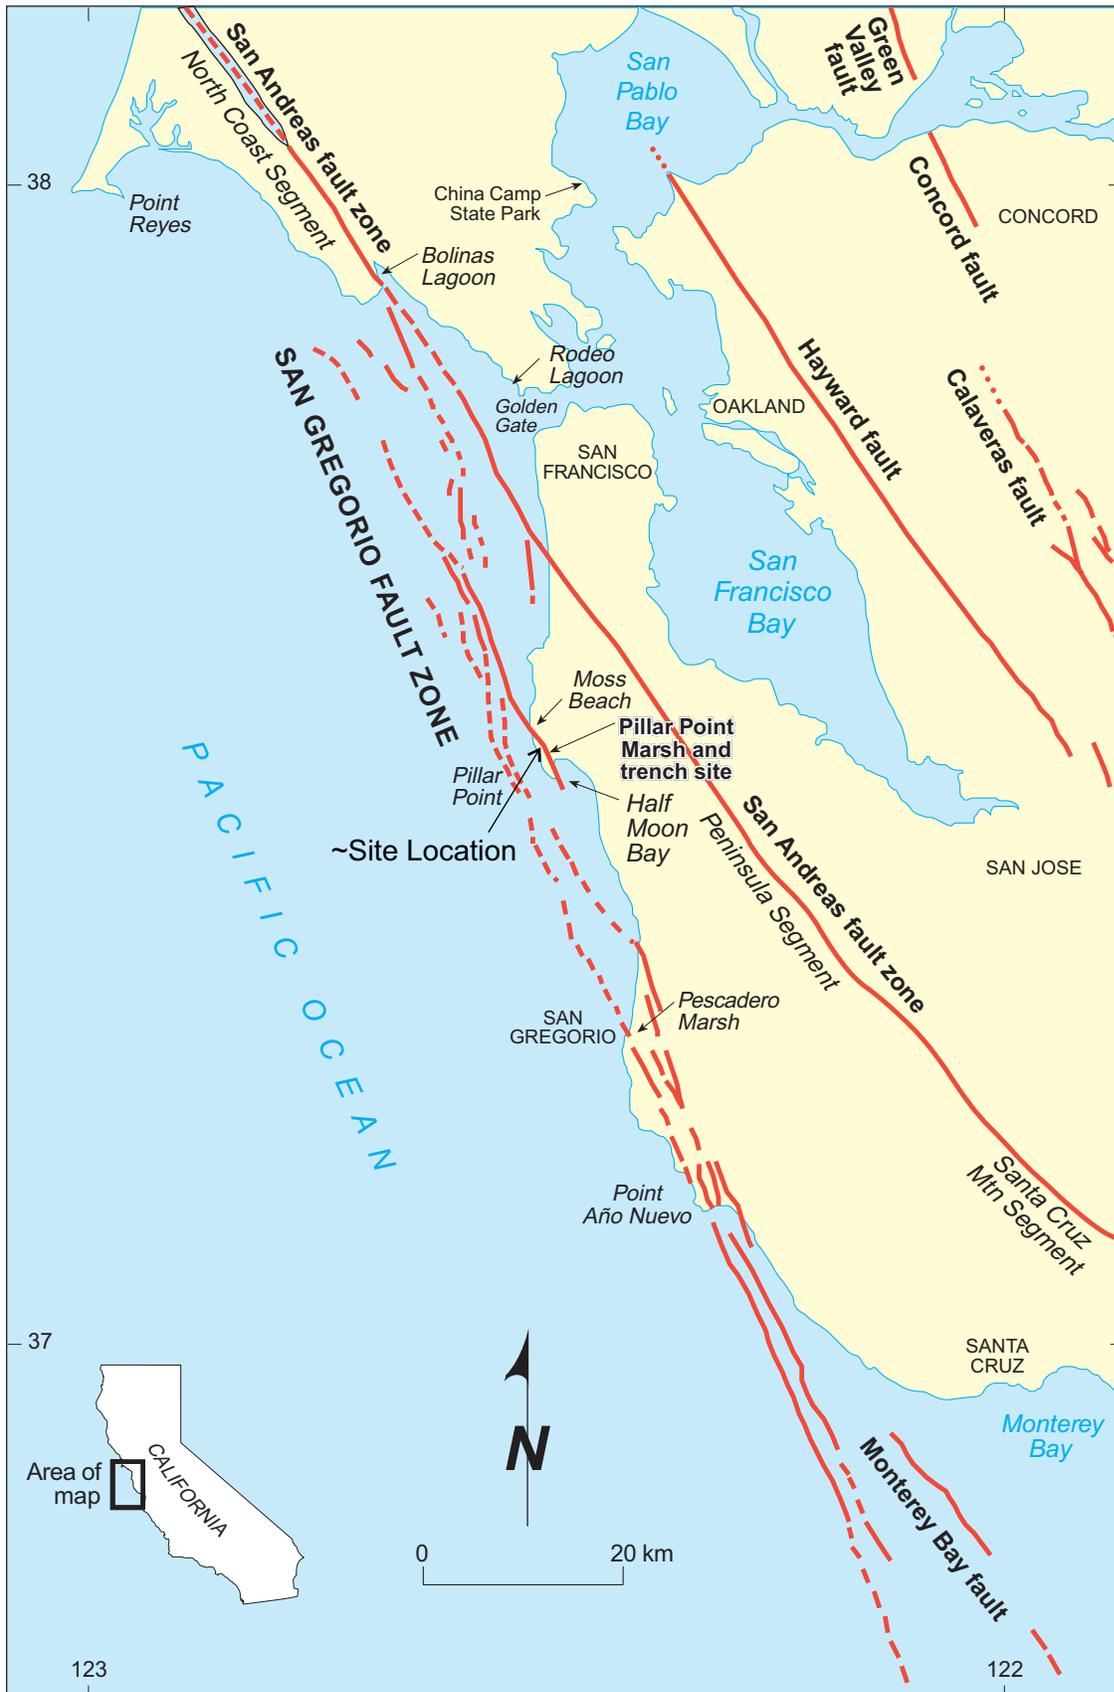
Figure 1. Map showing the San Gregorio fault zone and other principal Holocene faults in the San Francisco Bay area. Fault locations modified from Jennings (1994).

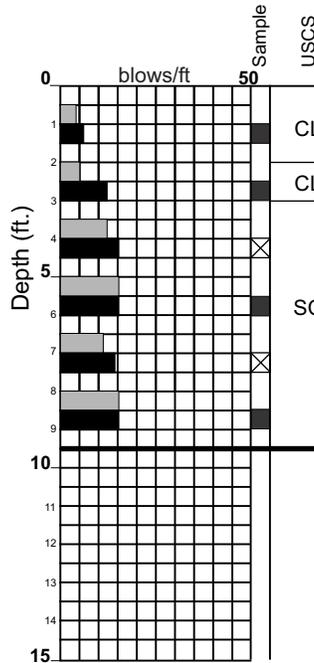
Elevation ~89 ft. Date 01/23/18

-200 Sieve (%)	Dry Density (pcf)	Moisture Content %	Blows/Foot (SPT)	Pocket Pen (tsf)	Torvane Pen (tsf)
	91.2	22.6	10	1.50	0.35
	101.6	19.4	17	3.00	0.65
			27		
	111.2	18.4	30		
			25		
	117.0	18.5	30

CL	Black Sandy CLAY, damp, stiff (loose in upper 1' from tilling) (Fill/Topsoil)
CL	Gray & strong brown mottled Sandy CLAY, damp, very stiff, very plastic (Residual Soil)
SC	Gray & strong brown variegated Clayey fine- to medium-grained SAND with coarse sand-size decomposed feldspar clasts, medium dense to dense (Terrace Deposits)

Terminated @ 9½'

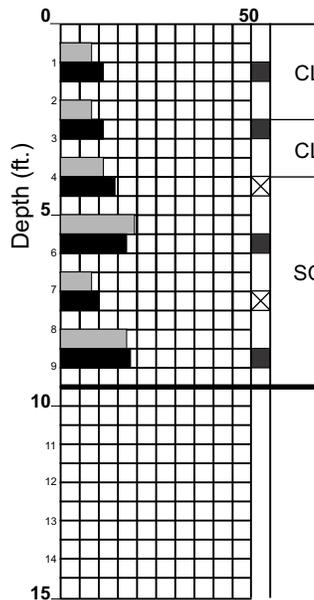
Elevation ~85 ft. Date 01/23/18

101.0	20.2	19	1.25	0.50
70	98.0	23.2	18	2.00	0.70
			25		
	111.5	18.6	35		
			18		
	113.5	14.6	25

CL	Dark brown Sandy CLAY, damp, very stiff (loose in upper 1' from tilling) (Fill/Topsoil)
CL	Gray & strong brown mottled Sandy CLAY, damp, very stiff, very plastic (Residual Soil)
SC	Gray & strong brown variegated Clayey fine- to medium-grained SAND with coarse sand-size decomposed feldspar clasts, medium dense to dense (Terrace Deposits)

Terminated @ 9½'

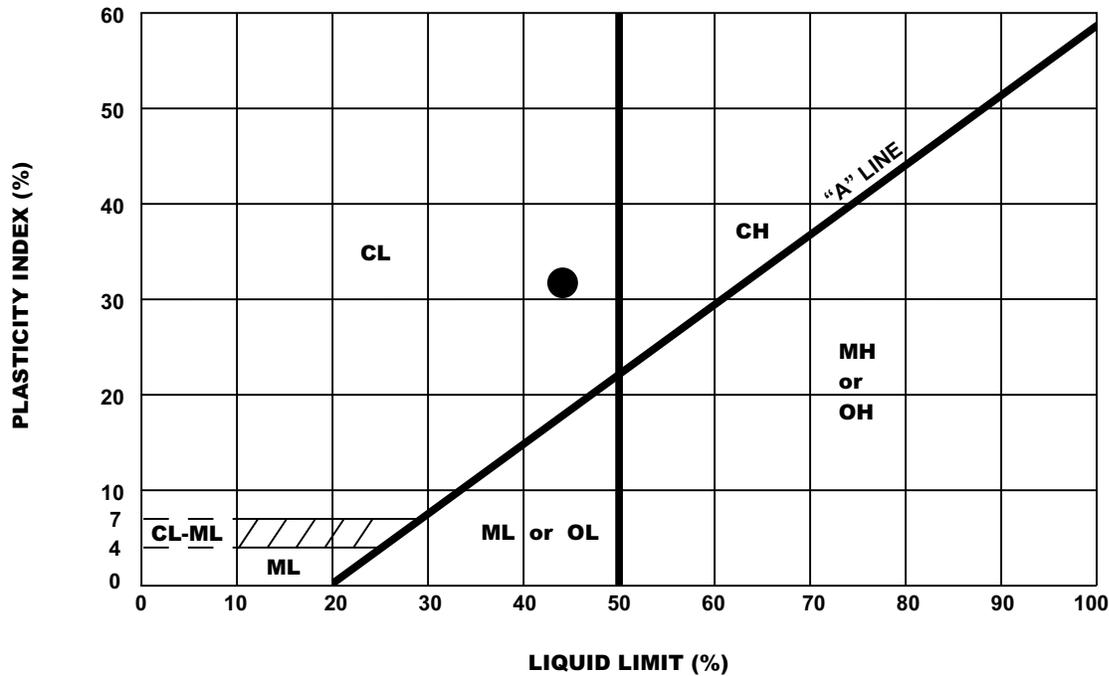
KEY SYMBOL	BORING NO.	SAMPLE DEPTH (feet)	NATURAL WATER CONTENT (%)	LIQUID LIMIT (%)	PLASTICITY INDEX (%)	PASSING NO. 200 SIEVE (%)	LIQUIDITY INDEX	USCS
●	B-2	3'	23	44	32	70	0.31	CL

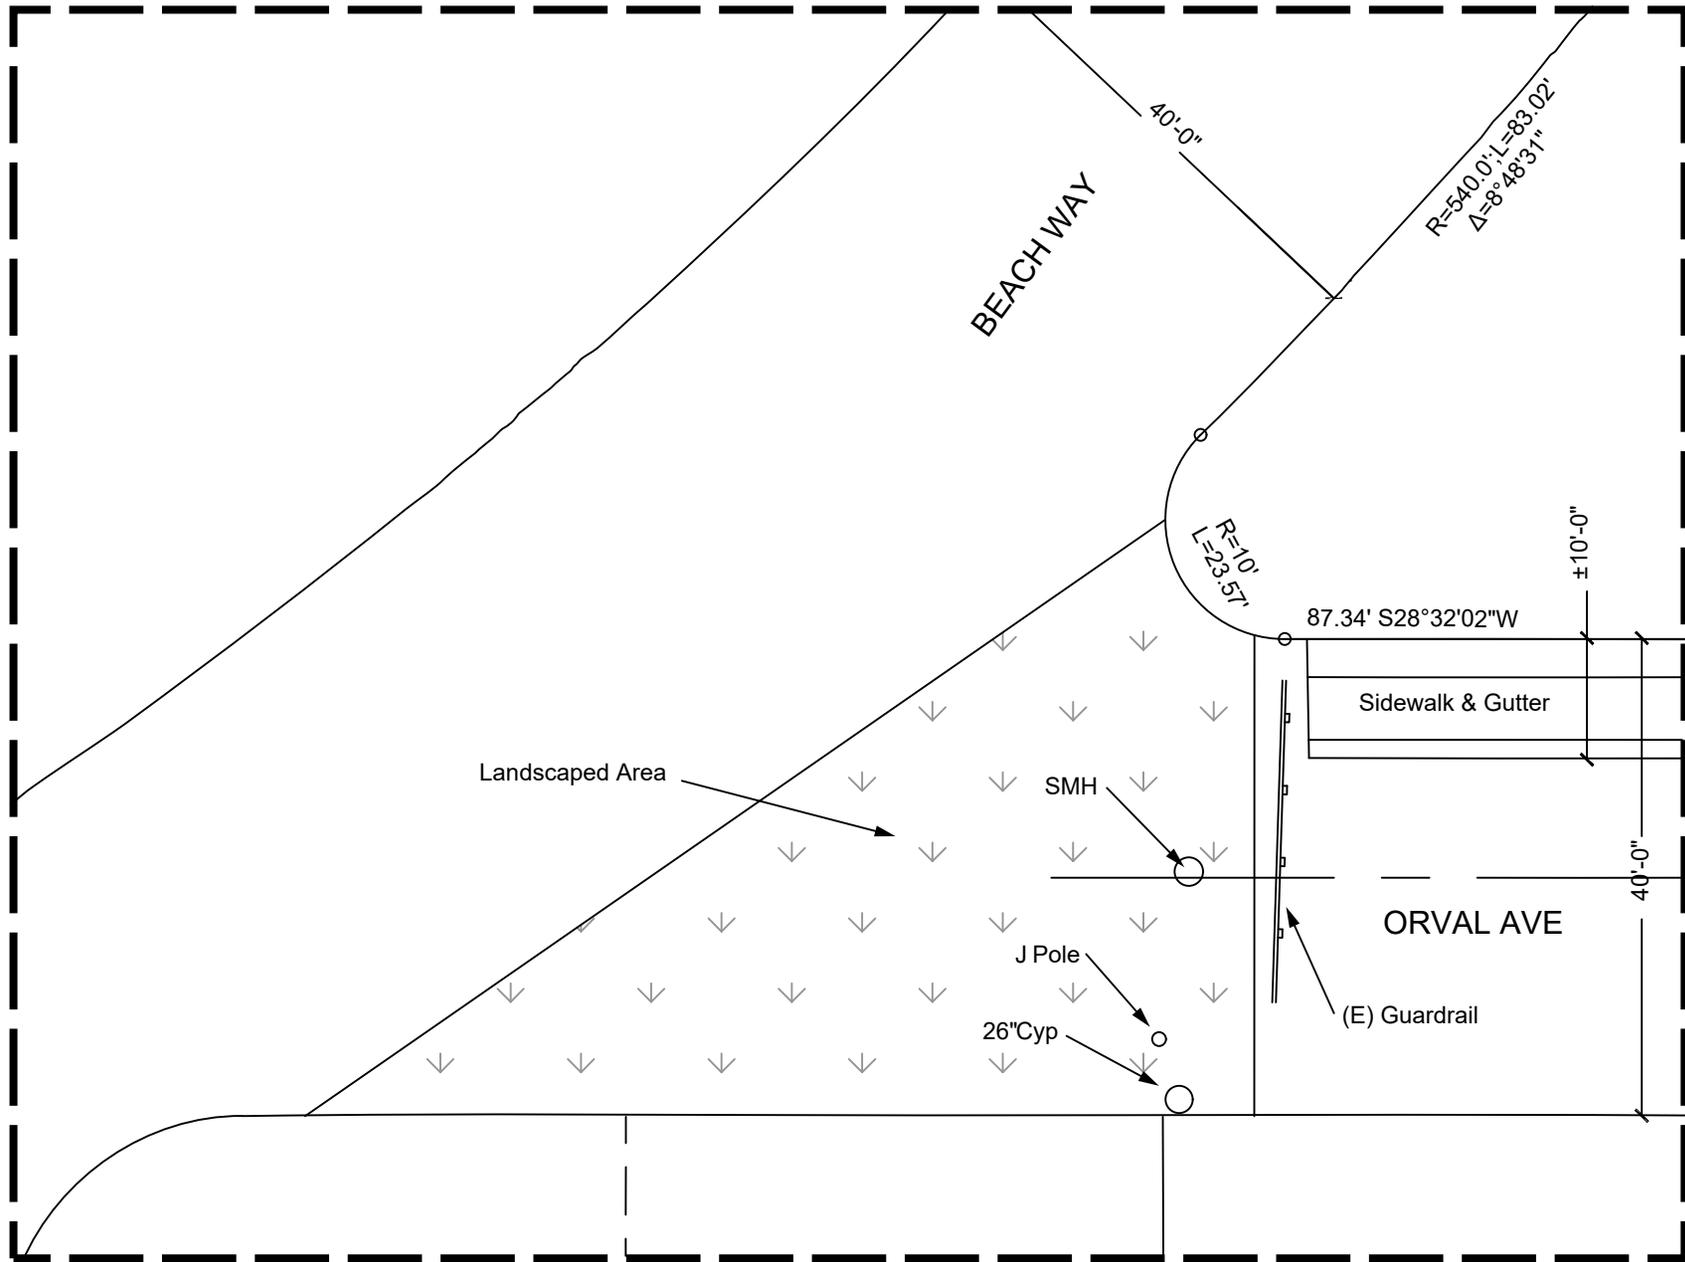
1/16"=1'

Existing Intersection Conditions

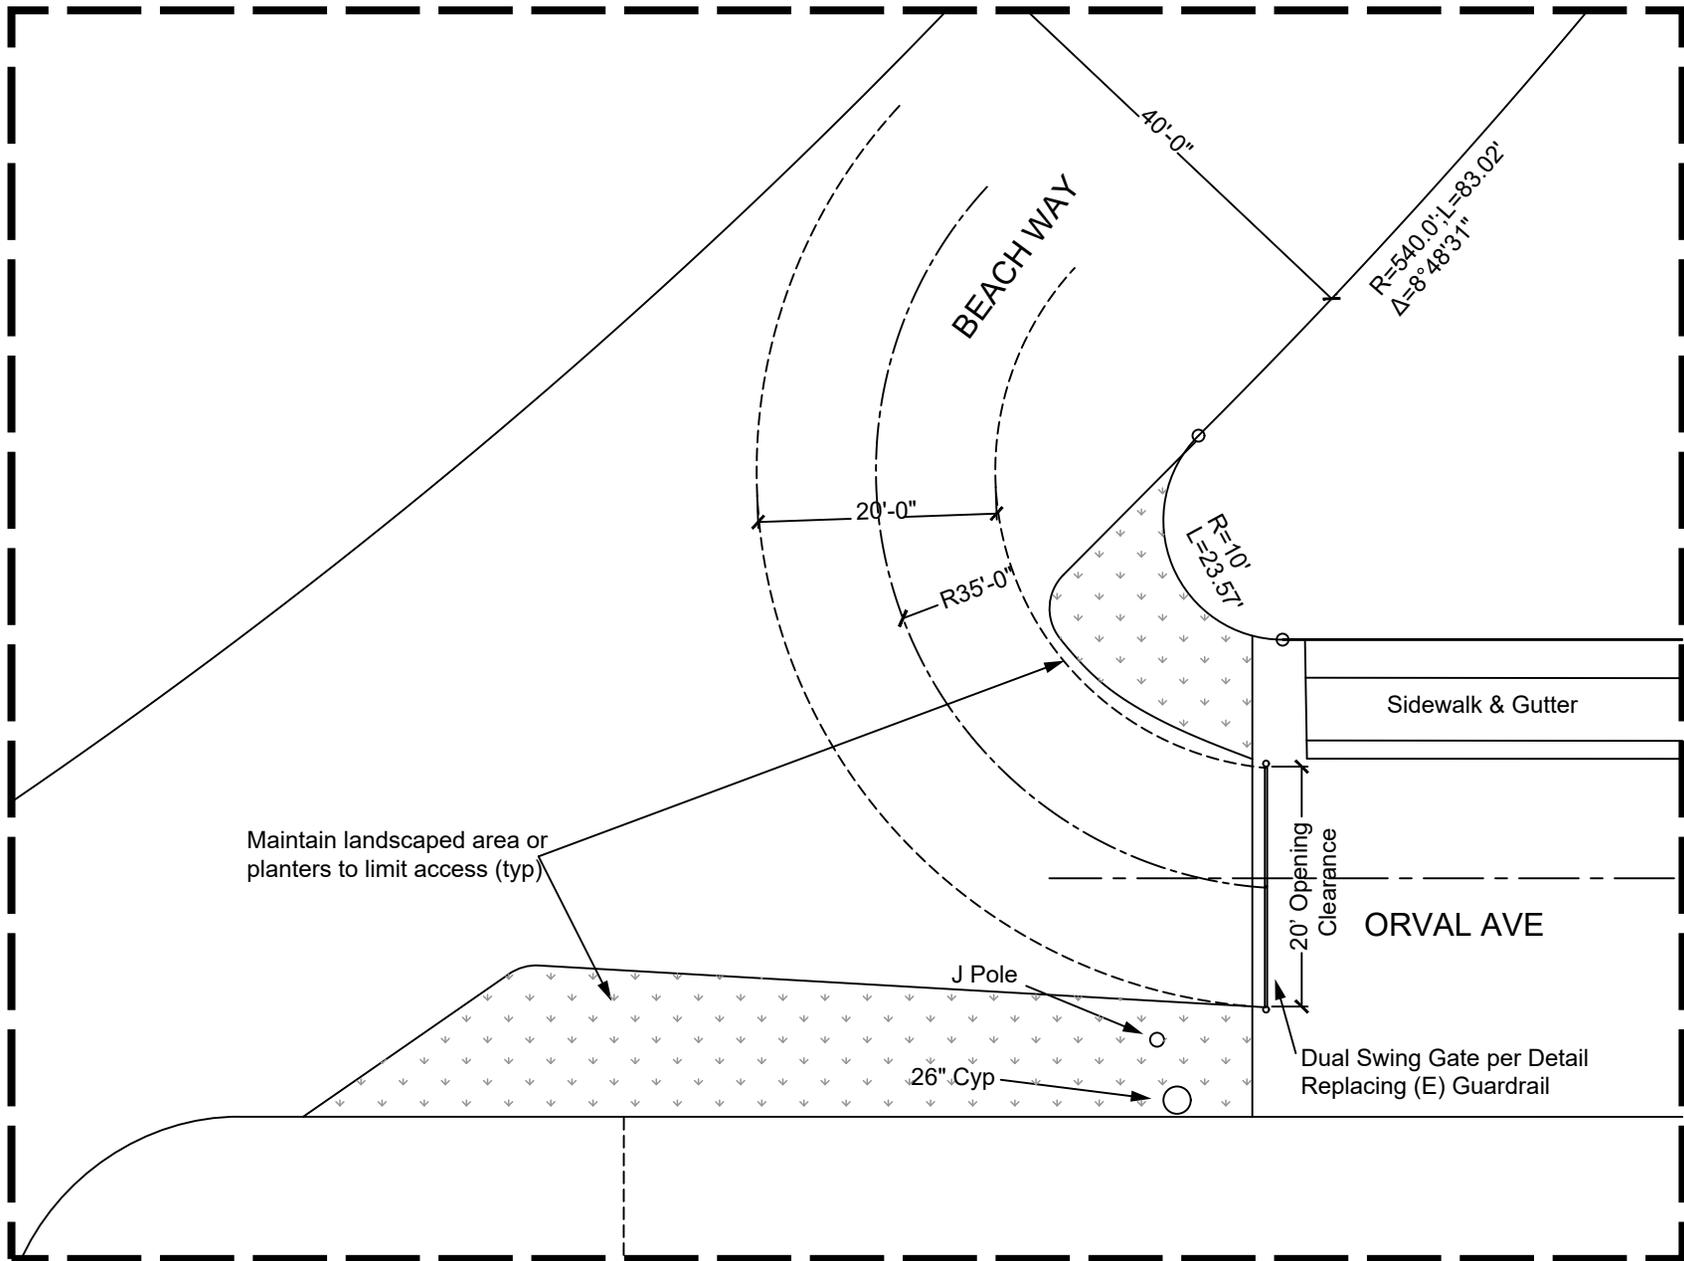
1/16"=1'

Proposed Gate Area & Turn Radius

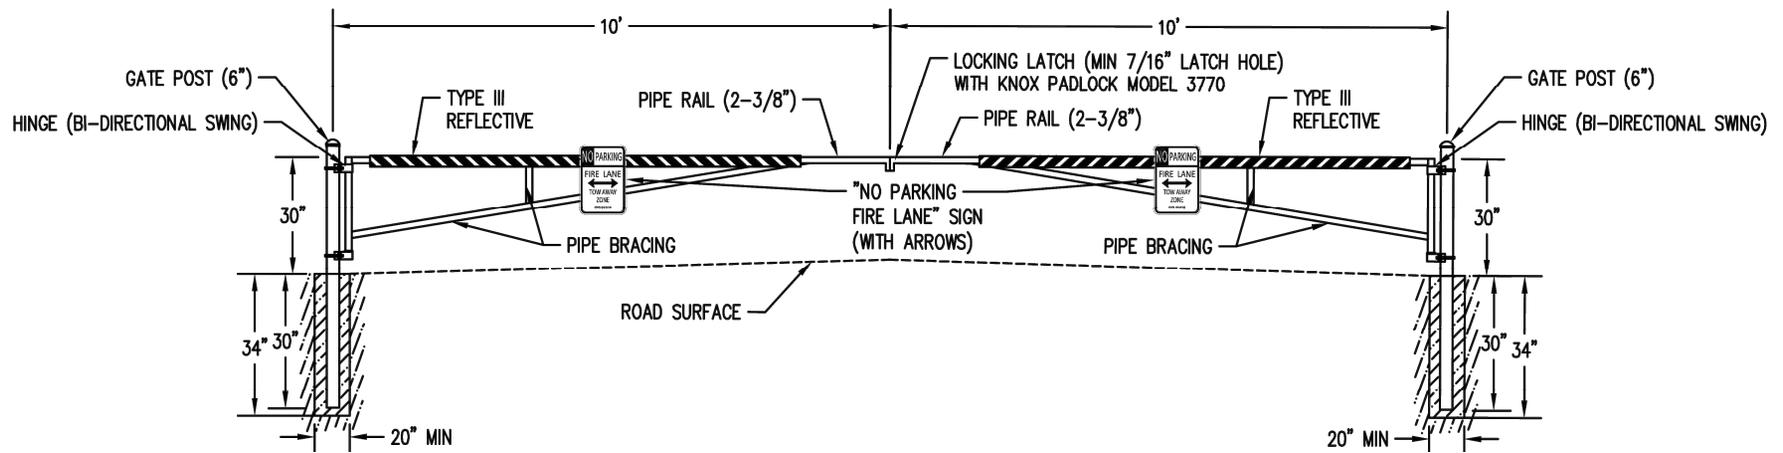
N.T.S.

Dual Swing Gate Detail
